SESM 16-03

**An Earthquake Urban Search and  
Rescue Model Illustrated with a  
Hypothetical  $M_w$  7.0 Earthquake on the  
Hayward Fault**

**Keith A. Porter**

July 2016

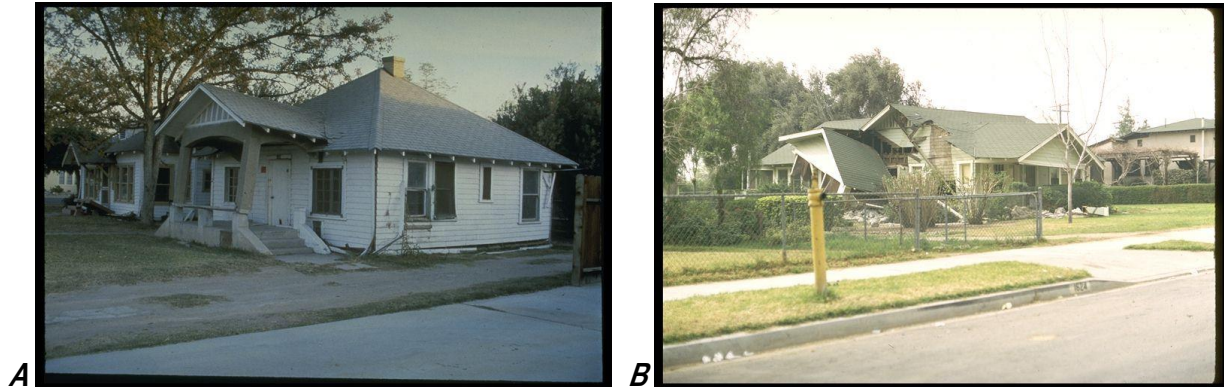
**Figure 6.** *A*, An example of the modal affected area (0 percent) of a collapsed wood frame building. The cripple wall collapsed in this Imperial Valley home in 1979. *B*, An example of the median affected area (6–10 percent): collapse of a porch roof. Photo credits: M. Hopper, and V. Bertero, respectively. Courtesy of the National Information Service for Earthquake Engineering, PEER-NISEE, University of California, Berkeley.

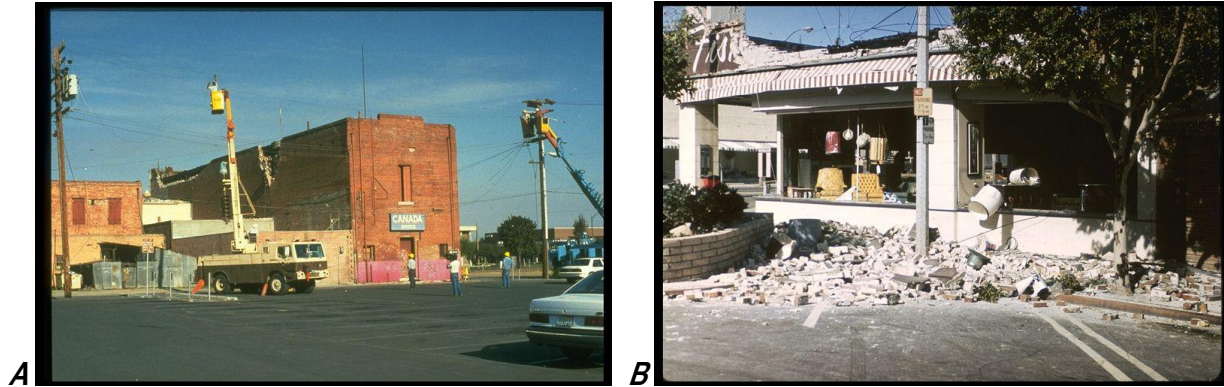
**Figure 7.** Examples of modal (A) and median (B) affected areas in unreinforced masonry (URM) buildings. Photo credits: J. Blacklock and E. Schader, respectively. Courtesy of the National Information Service for Earthquake Engineering, PEER-NISEE, University of California, Berkeley.

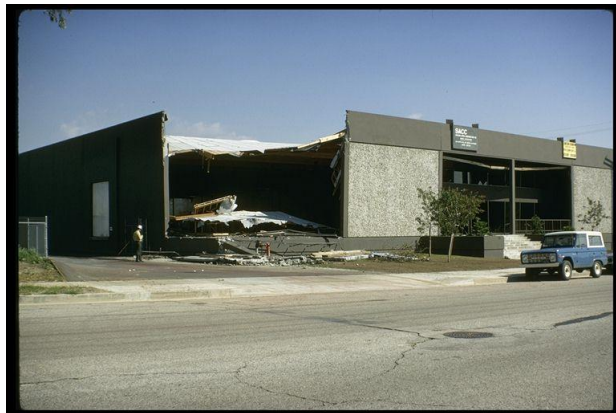
**Figure 8.** Example of both modal and median collapse of tilt-up. Photo credit: V. Bertero, courtesy of the National Information Service for Earthquake Engineering, PEER-NISEE, University of California, Berkeley.

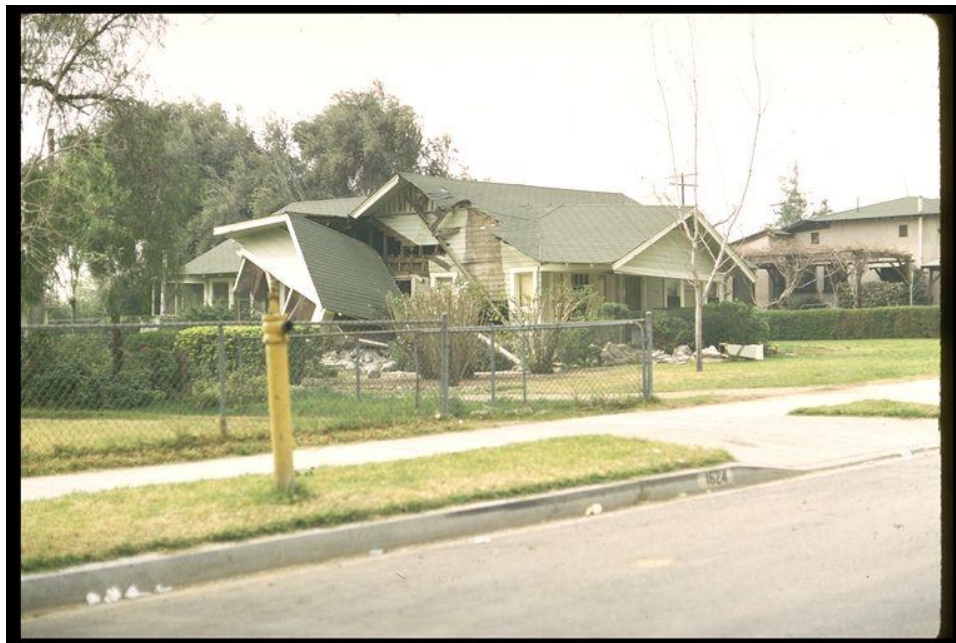
Approximately  $(120 \text{ ft}^2 \text{ porch}) / (1,500 \text{ ft}^2 \text{ house}) = 8.0\%$ .

Figure 2-1. Image showing damage to a wood frame house in the 1971 San Fernando, California, earthquake.

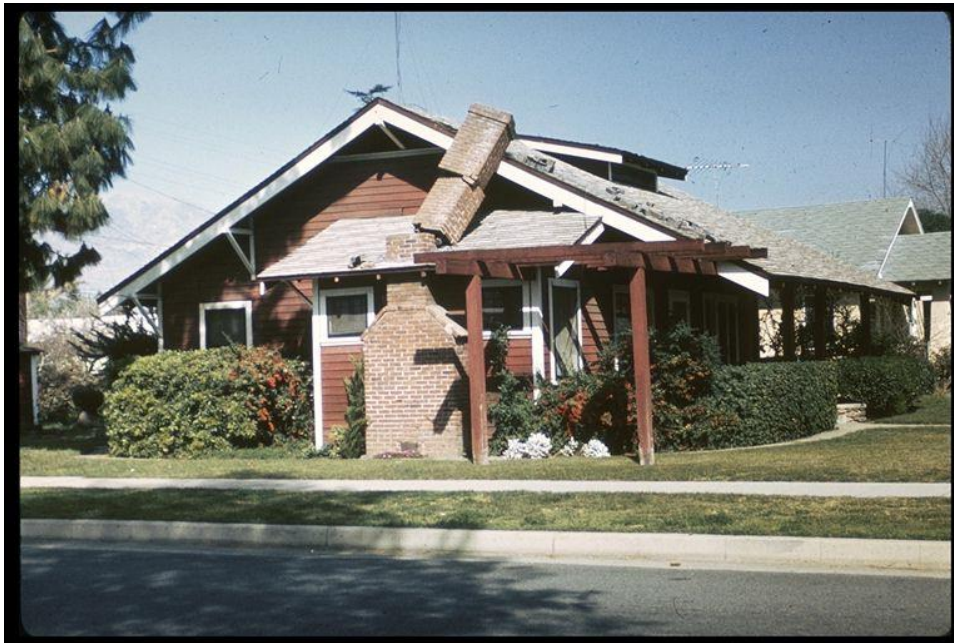
Figure 2-2. Image showing chimney damage in the 1971 San Fernando, California, earthquake.

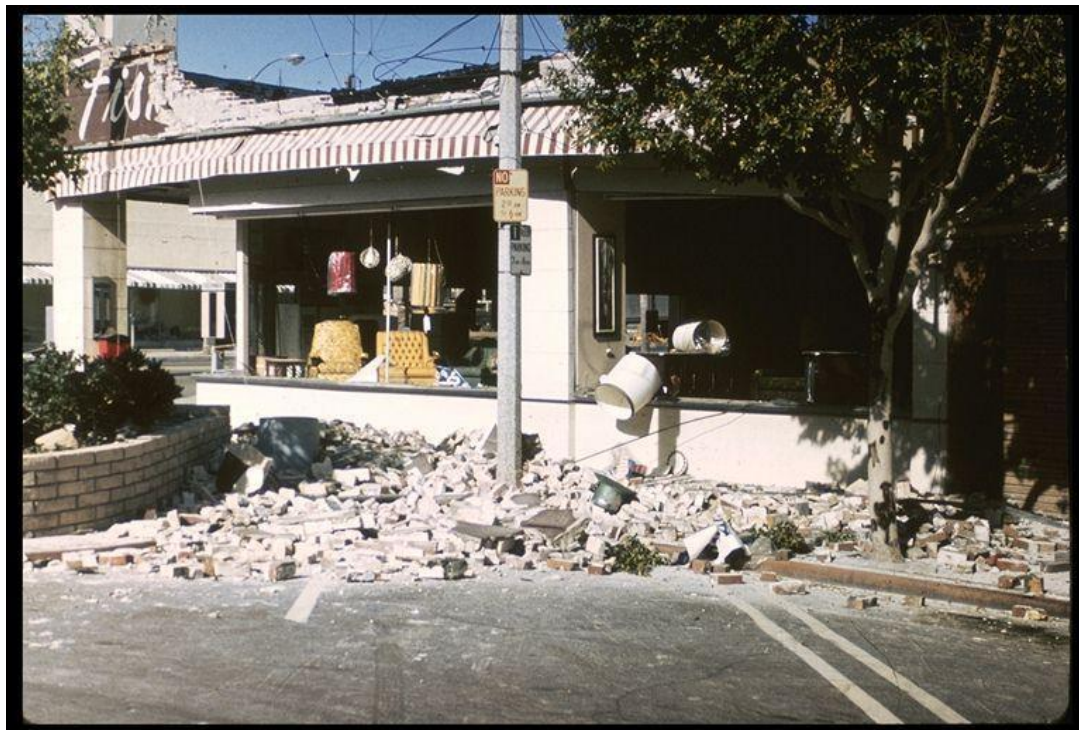
Plan area  $\approx 40 \text{ ft} \times 60 \text{ ft}$  (?); area littered by bricks  $\approx 30 \text{ ft} \times 15 \text{ ft} = 19\%$ .

**Figure 2-3.** Image showing furniture store damage in the 1971 San Fernando, California, earthquake.

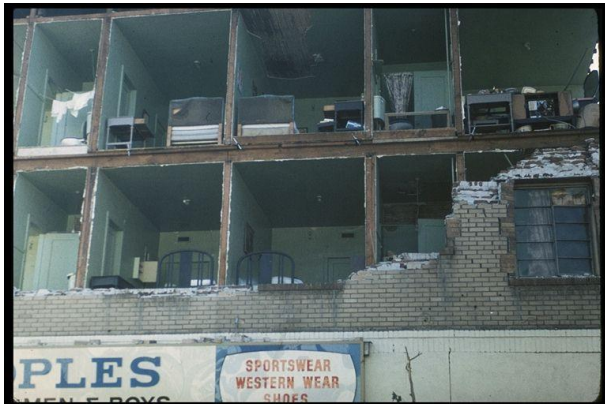
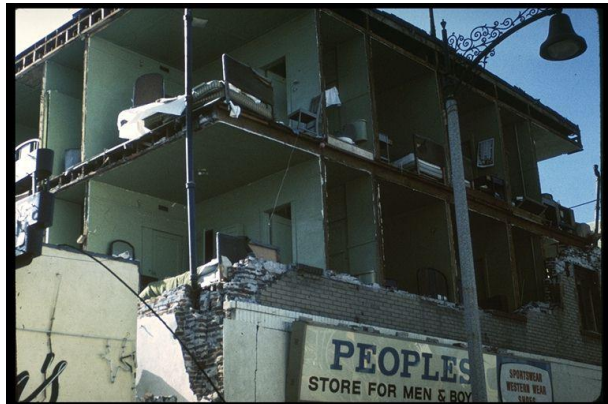
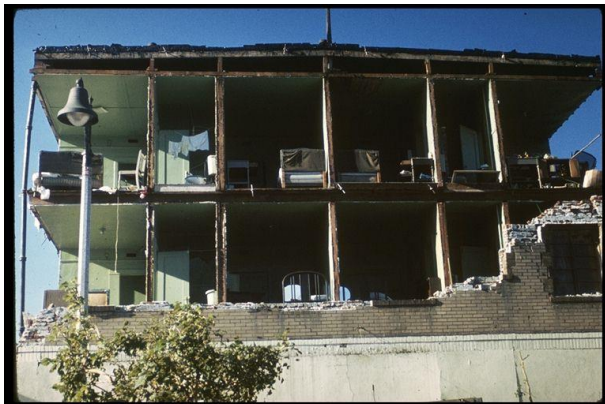
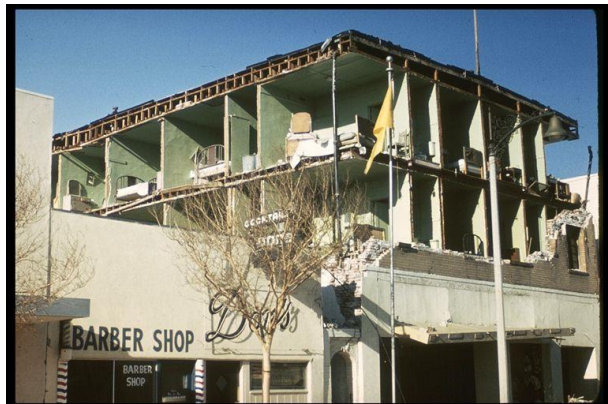
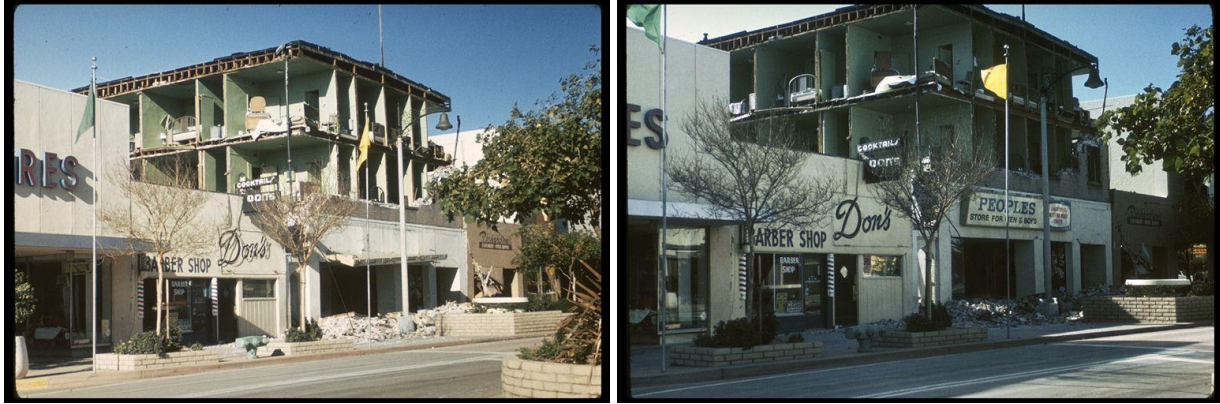
Plan area: 50 ft × 75 ft × 3 stories; masonry littering 250 ft (?) × 15 ft (?) = 3%.

**Figure 2-4.** Images showing damage to apartments over retail space in the 1971 San Fernando, California, earthquake.

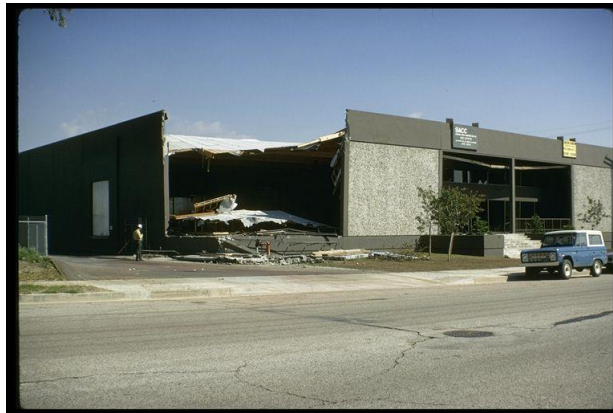
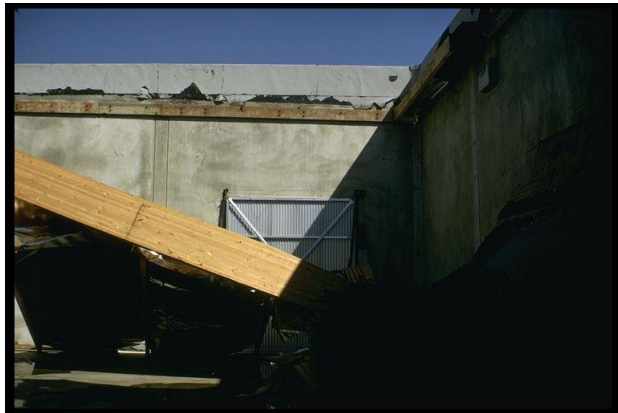
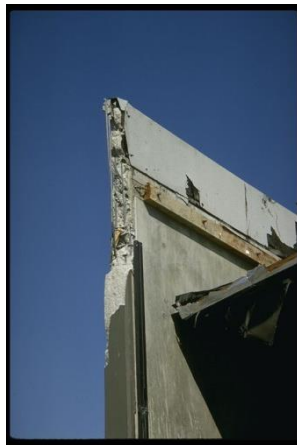
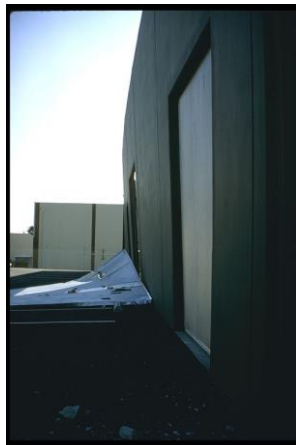
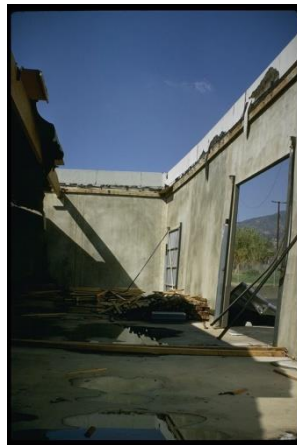
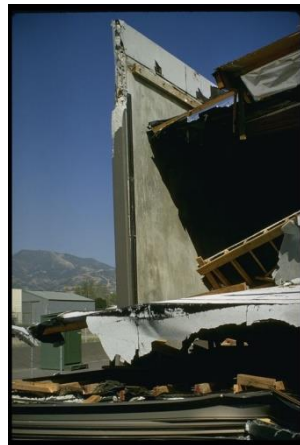
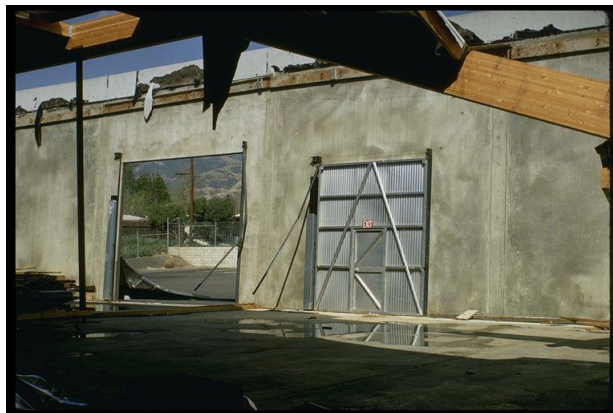
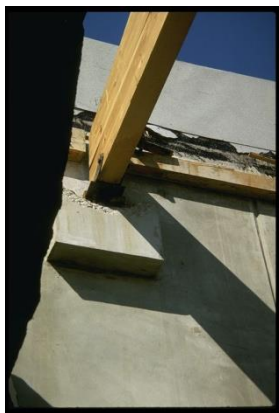
Address	Collapsed area, in square feet	Plan area, in square feet	Affected area, in percent
12975 Bradley Avenue	18,180	77,600	23%
13001 Bradley Avenue	6,400	85,050	8%
13069 Bradley Avenue	7,030	45,000	16%
15200 Bledsoe Street	3,700	19,800	19%
15151 Bledsoe Street	4,050	51,800	8%
12860 San Fernando Road	4,650	29,340	16%
12806 San Fernando Road	11,260	63,400	18%
12744 San Fernando Road	26,600	101,400	26%
12814 Bradley Avenue	2,400	15,600	15%

**Figure 2-5.** Images showing damage to industrial buildings in Bradley Tract, Los Angeles, in the 1971 San Fernando, California, earthquake.

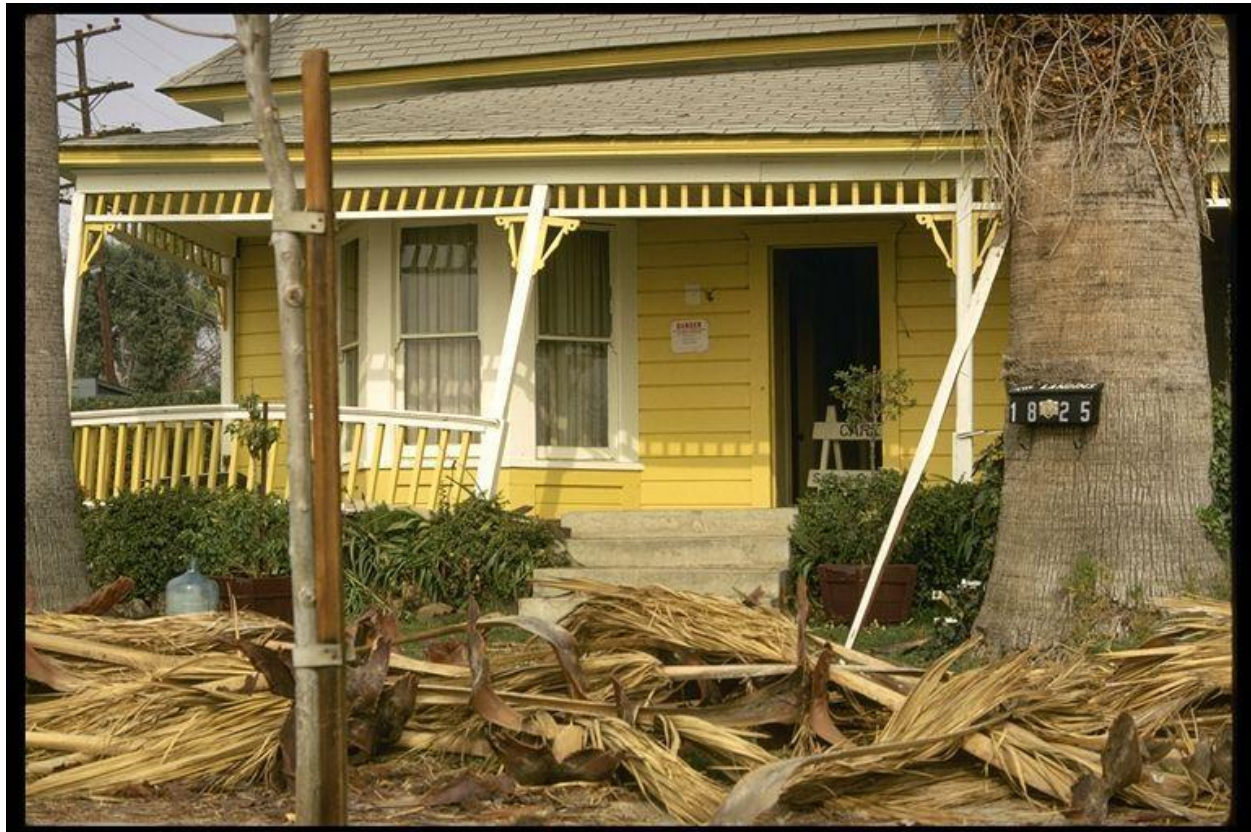
Plan area  $\approx 1,500 \text{ ft}^2$  (?); collapsed area where people could be trapped = 0%.

**Figure 2-6.** Image showing damage to industrial buildings in Bradley Tract, Los Angeles, in the 1971 San Fernando, California, earthquake.

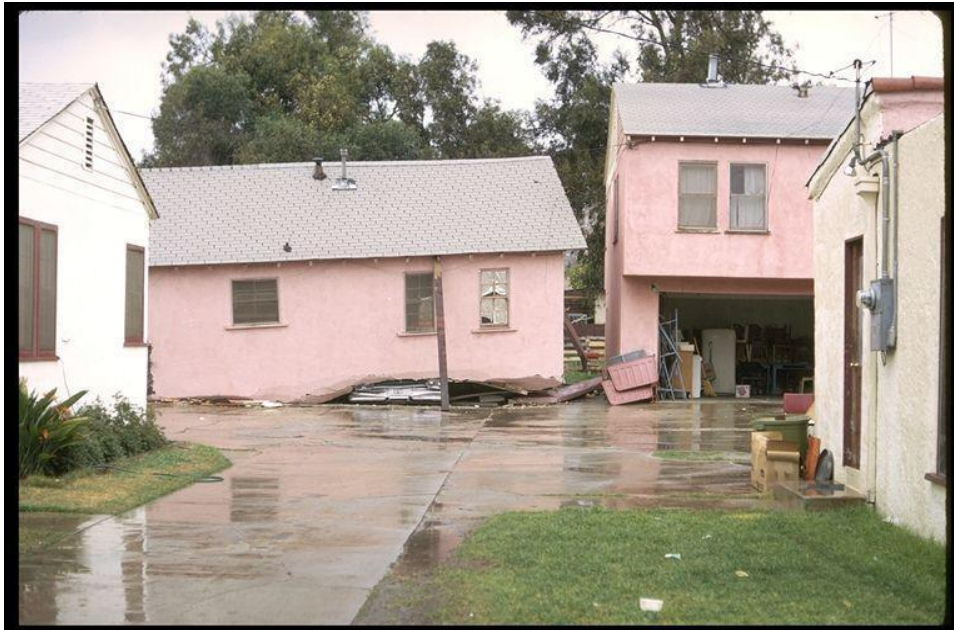
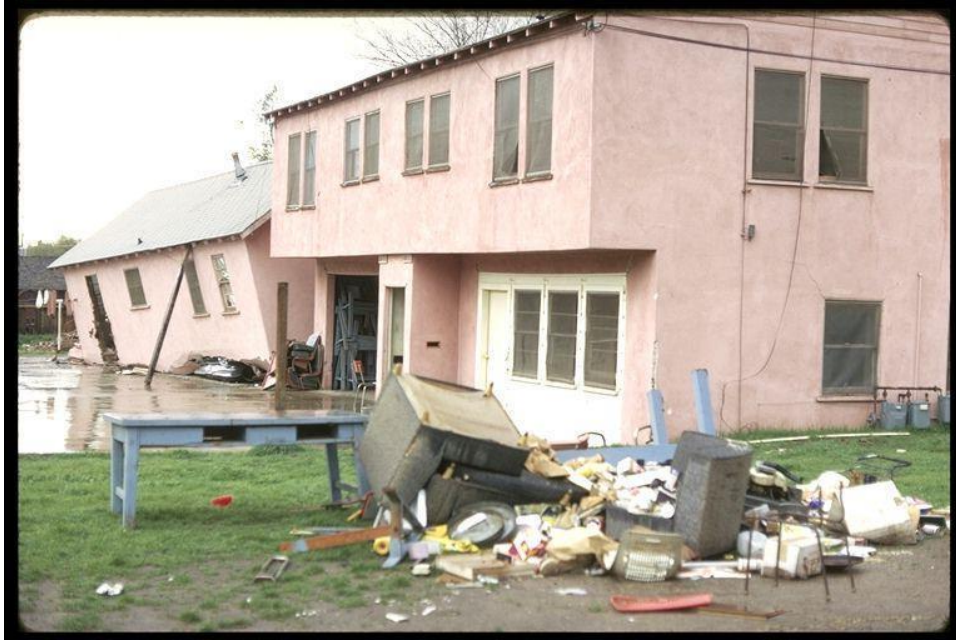
Building area = 30 ft × 20 ft (?) × 2; collapsed area = 30 ft × 20 ft (?) × 1 = 50%.

Figure 2-7. Images showing soft-story failure in the 1971 San Fernando, California, earthquake.

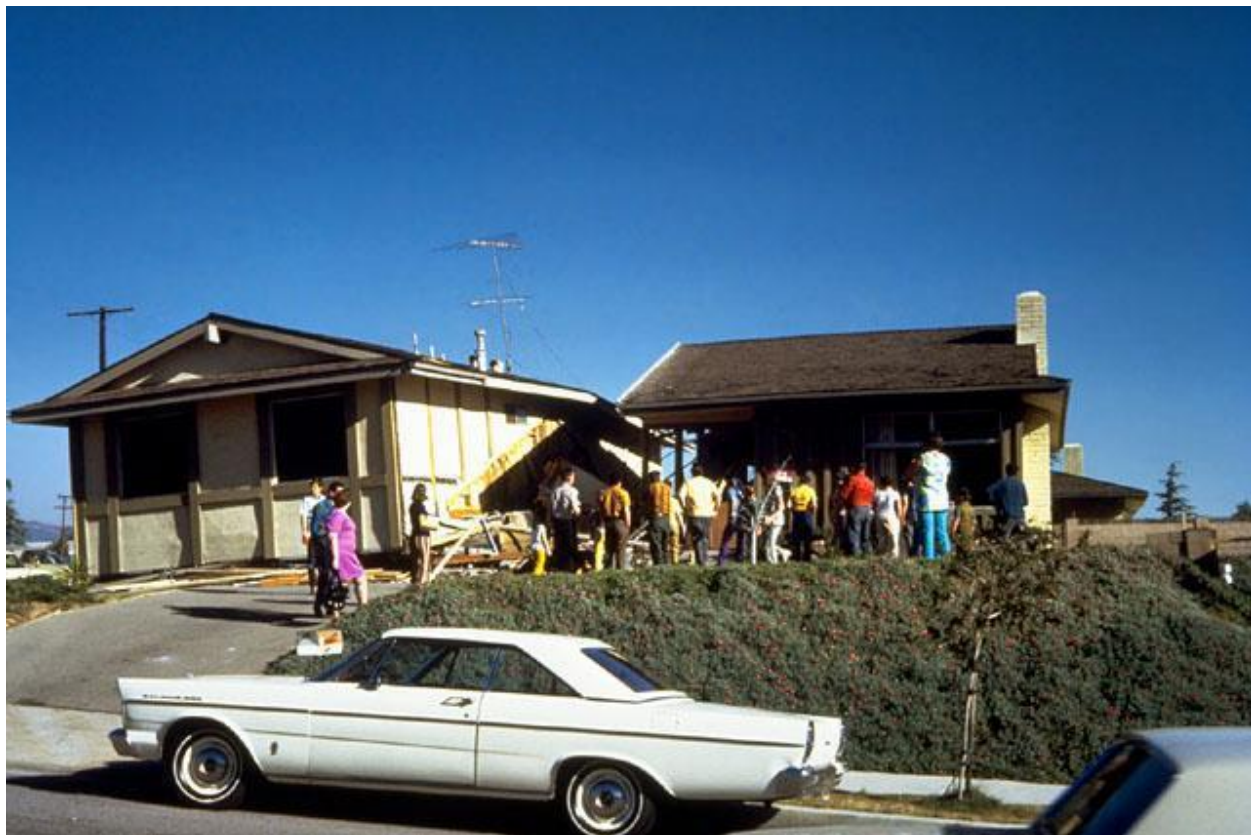
Building area  $\approx 15 \text{ ft} \times 30 \text{ ft} \times 3$ ; collapsed area  $\approx 15 \text{ ft} \times 30 \text{ ft} \times 1 = 33\%$ .

Figure 2–8. Image showing damage to a split-level house in the 1971 San Fernando, California, earthquake.

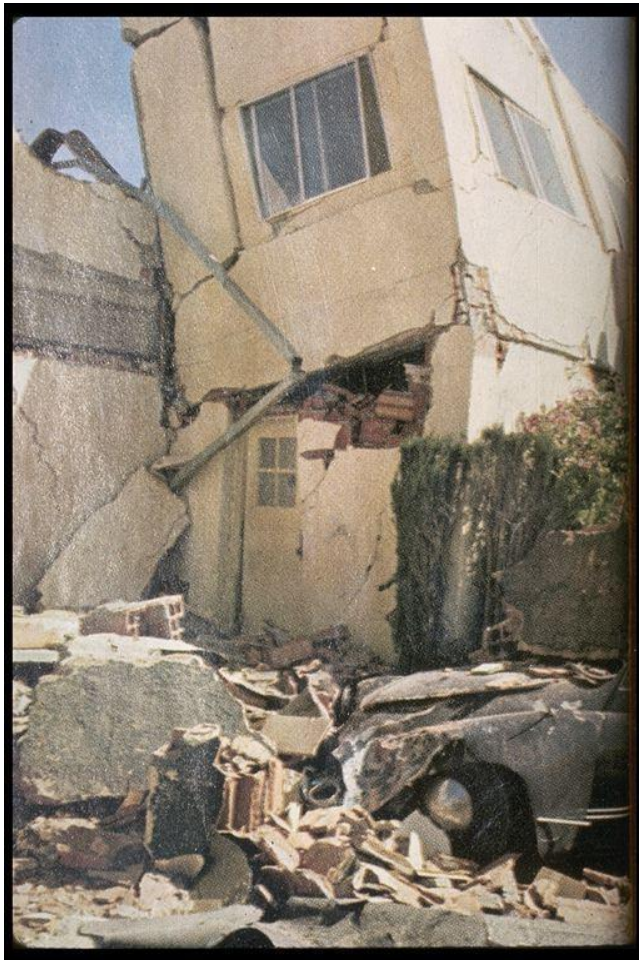
Collapsed area: from this photo, it looks as if the lower story collapsed, so 50%.

**Figure 2-9.** Image showing severe damage to masonry building at the Veterans Administration Hospital (Sylmar) in the 1971 San Fernando, California, earthquake.

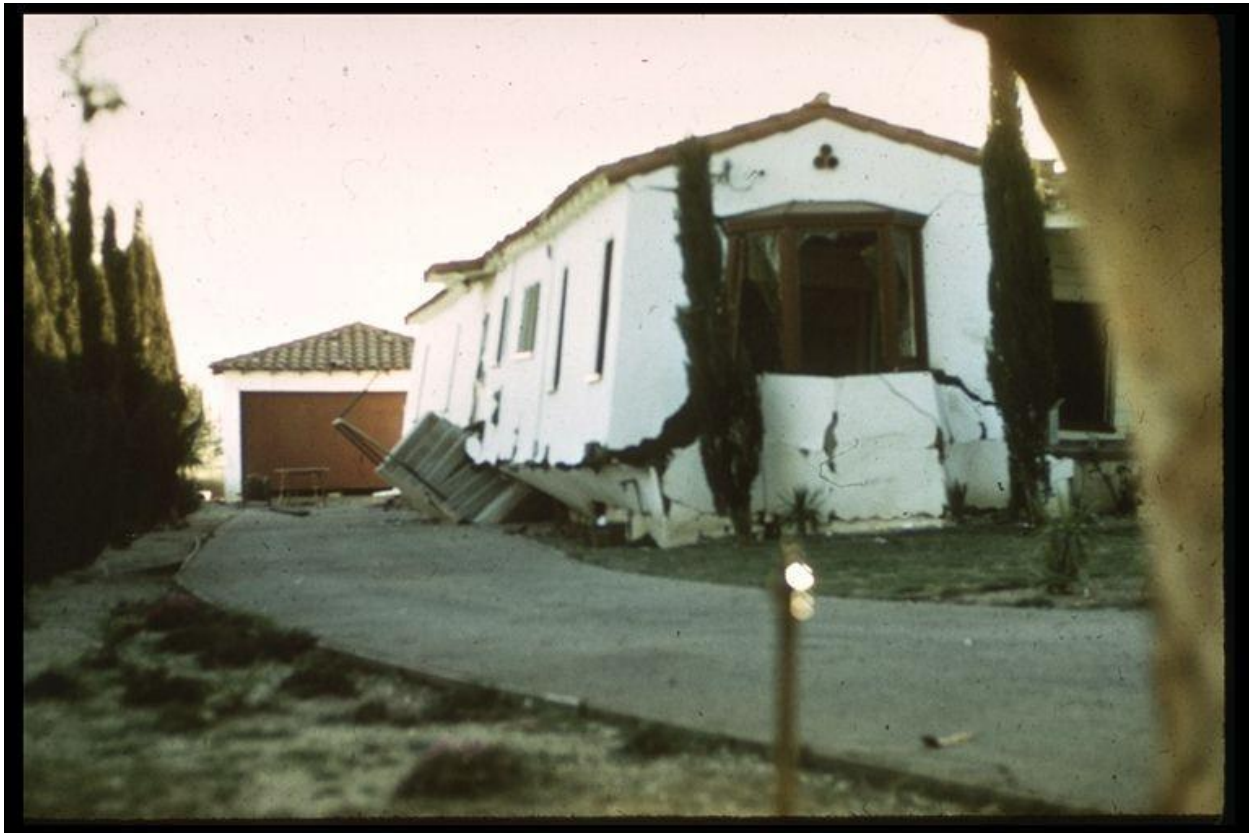
Although the cripple wall collapsed, the living space does not appear to have experienced any drop in a roof or ceiling relative to the floor, so 0%.

**Figure 2–11.** Image showing damage to older dwellings in the 1971 San Fernando, California, earthquake.

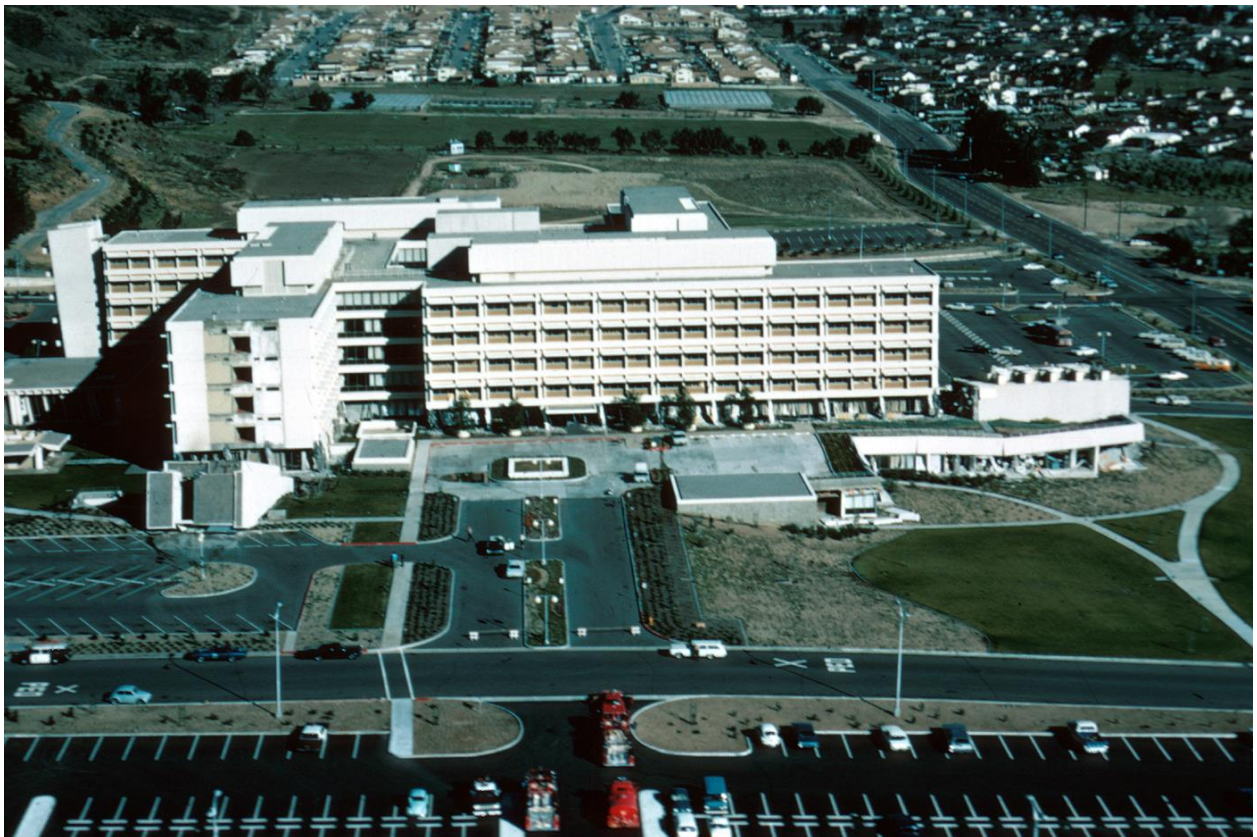
Each wing appears to be approximately  $240 \text{ ft} \times 50 \text{ ft} \times 5 \text{ stories} \times 4 \text{ wings} = 240,000 \text{ ft}^2$ . The collapsed stair towers appear to be approximately  $20 \text{ ft} \times 40 \text{ ft} \times 5 \text{ stories} \times 2 \text{ towers} = 8,000 \text{ ft}^2$ , or 3.3%.

**Figure 2–13.** Image showing collapsed and leaning stair towers at Olive View Hospital, Sylmar, in the 1971 San Fernando, California, earthquake.

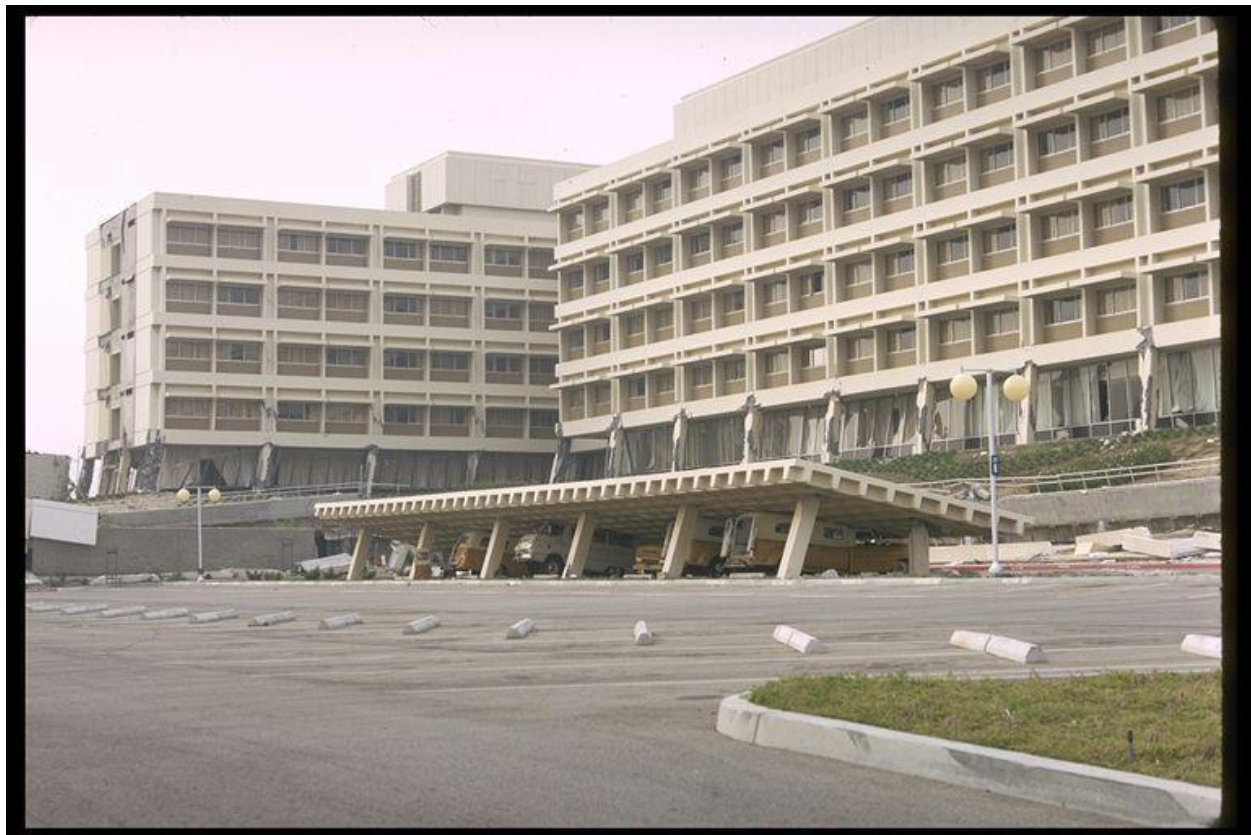
By inspection (an engineering term meaning “just by looking at it”), 100%.

**Figure 2-14.** Image showing a collapsed ambulance garage at Olive View Hospital, Sylmar, in the 1971 San Fernando, California, earthquake.

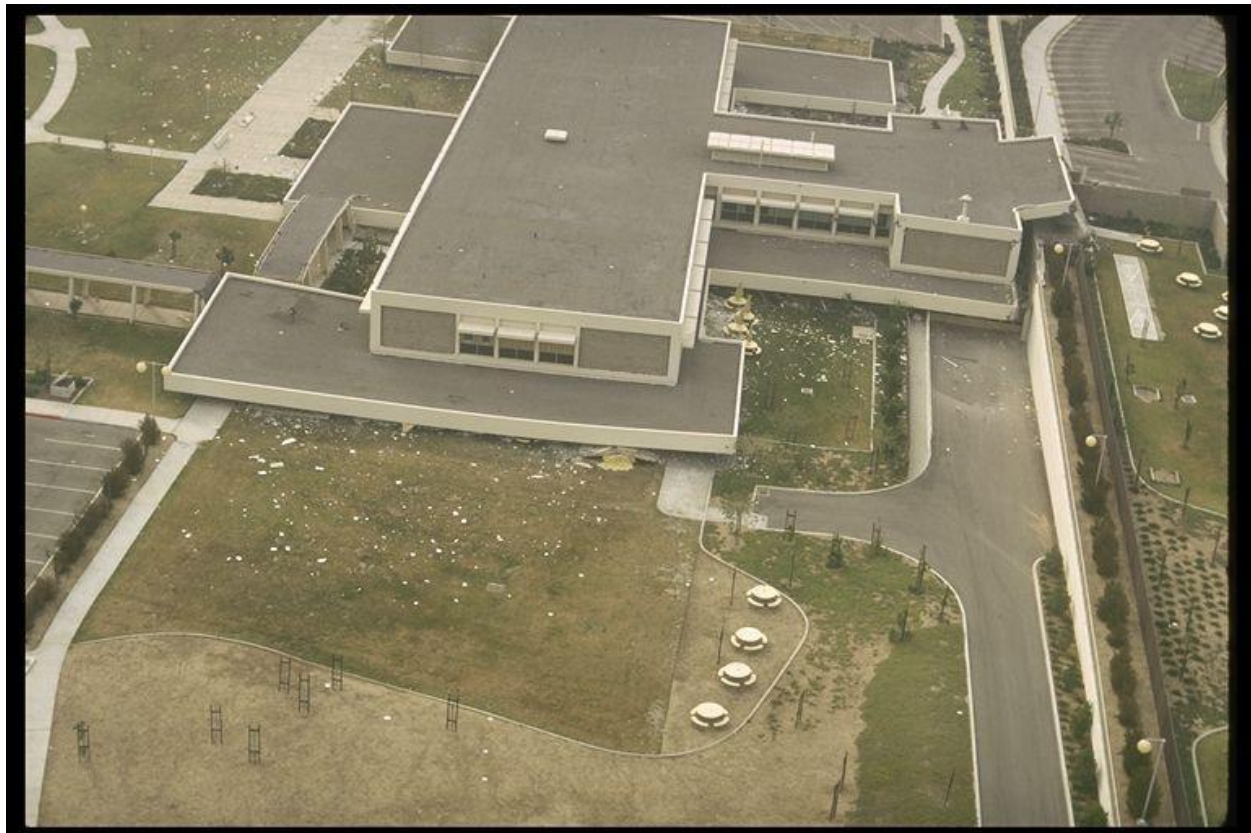
Collapsed area: it appears as if the first story was about twice the area of the second, and all of the area of the first story has collapsed, so 67%.

**Figure 2–15.** Image showing soft-story collapse of Psychiatric Building at Olive View Hospital, Sylmar, in the 1971 San Fernando, California, earthquake.

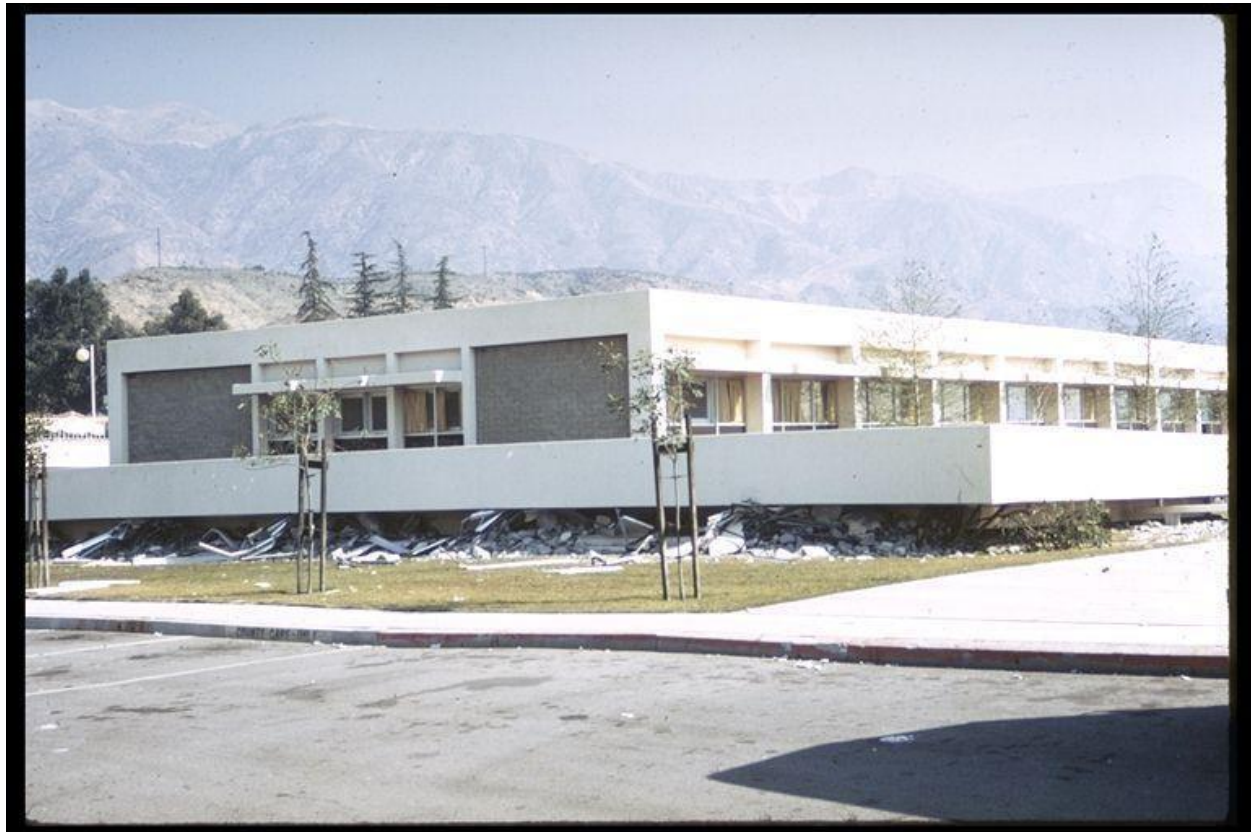
This is another view of the previous building.

**Figure 2–16.** Image showing first story collapse of Psychiatric Building at Olive View Hospital, Sylmar, in the 1971 San Fernando, California, earthquake.

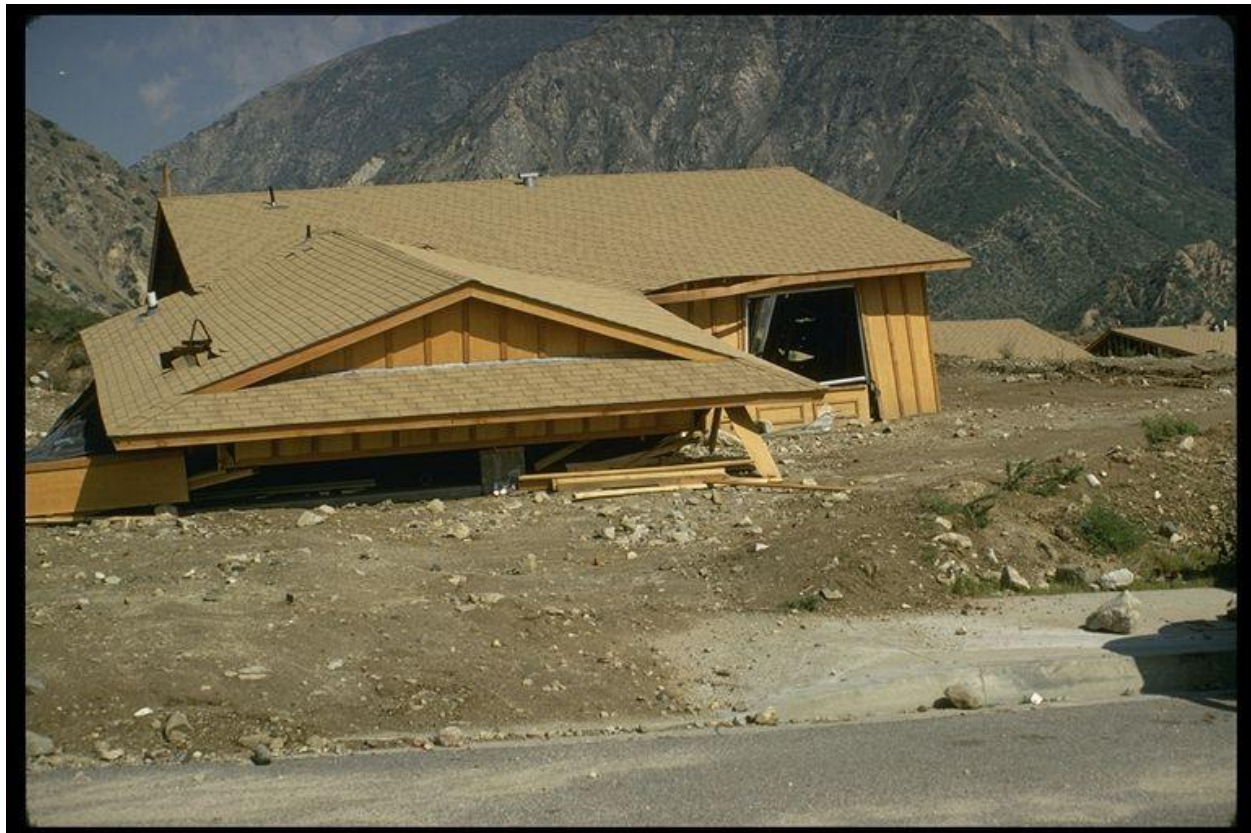
There is no other view of this house. It looks as if the garage (front left) and perhaps half of the living space (in the rear) at least partially collapsed, so say 67%.

Figure 2-17. Image showing a collapsed wood frame house in the 1971 San Fernando, California, earthquake.

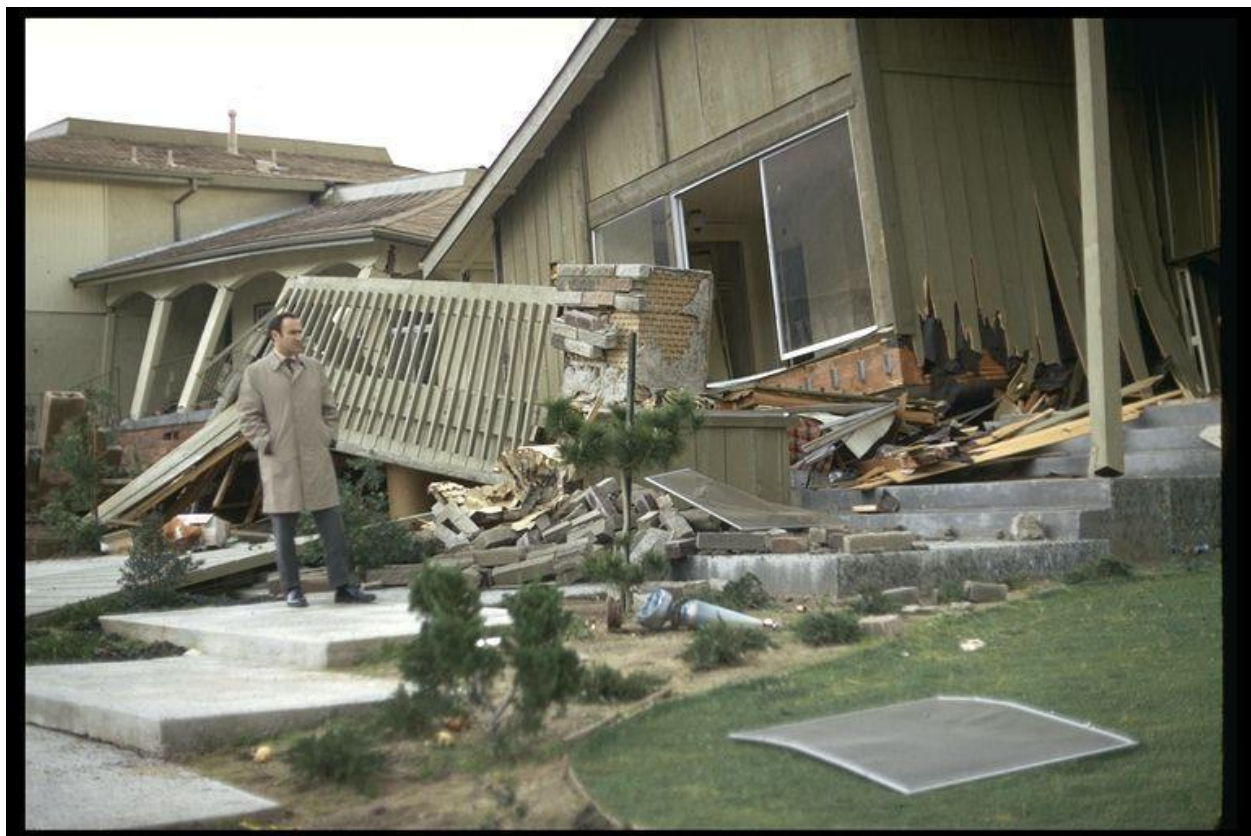
There are no other views of this house. Judging by the description, this building resembled S4514 in layout, so say again 33%.

**Figure 2–18.** Image showing soft-story failure in a wood frame house in the 1971 San Fernando, California, earthquake.

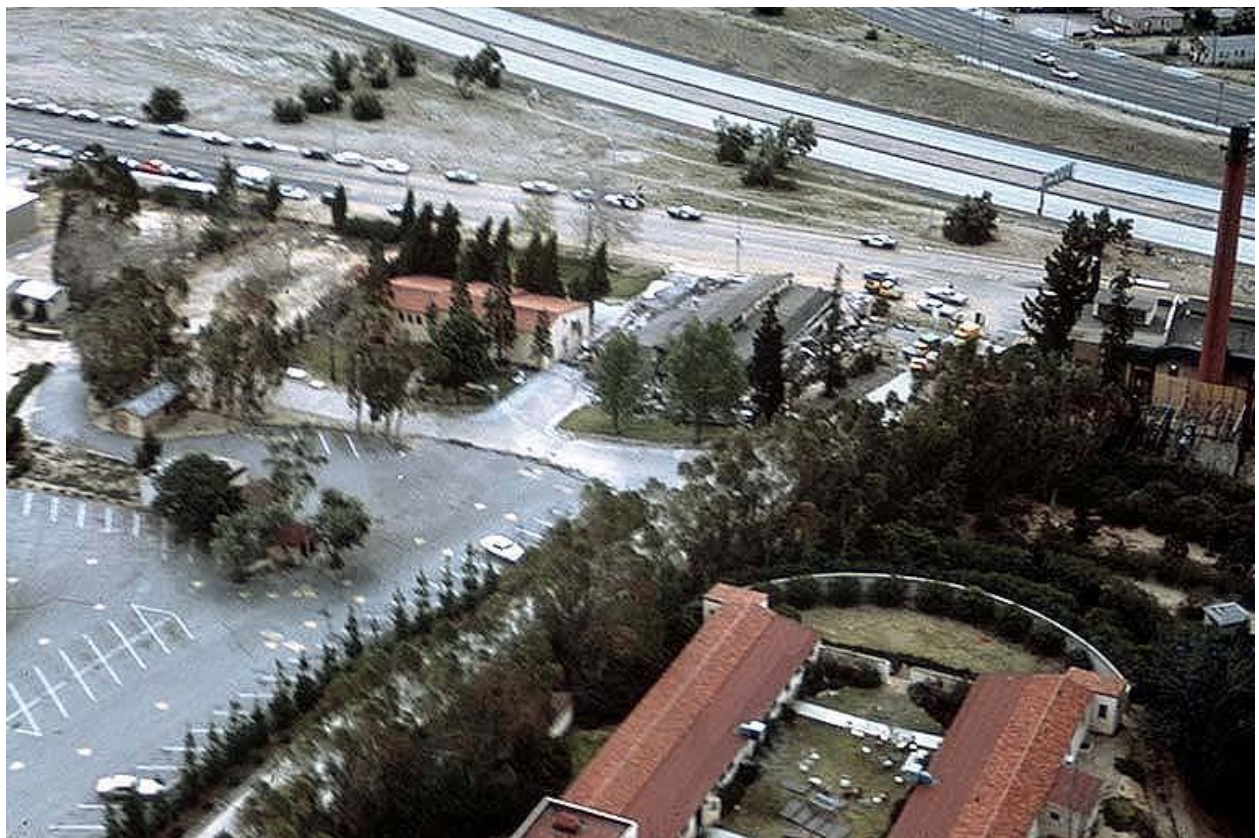
The collapsed building is the gray-roofed one, which appears to have been a one-story building whose entire area collapsed. 100%.

**Figure 2–19.** Image showing damage to the Veterans Administration Hospital, Sylmar, in the 1971 San Fernando, California, earthquake.

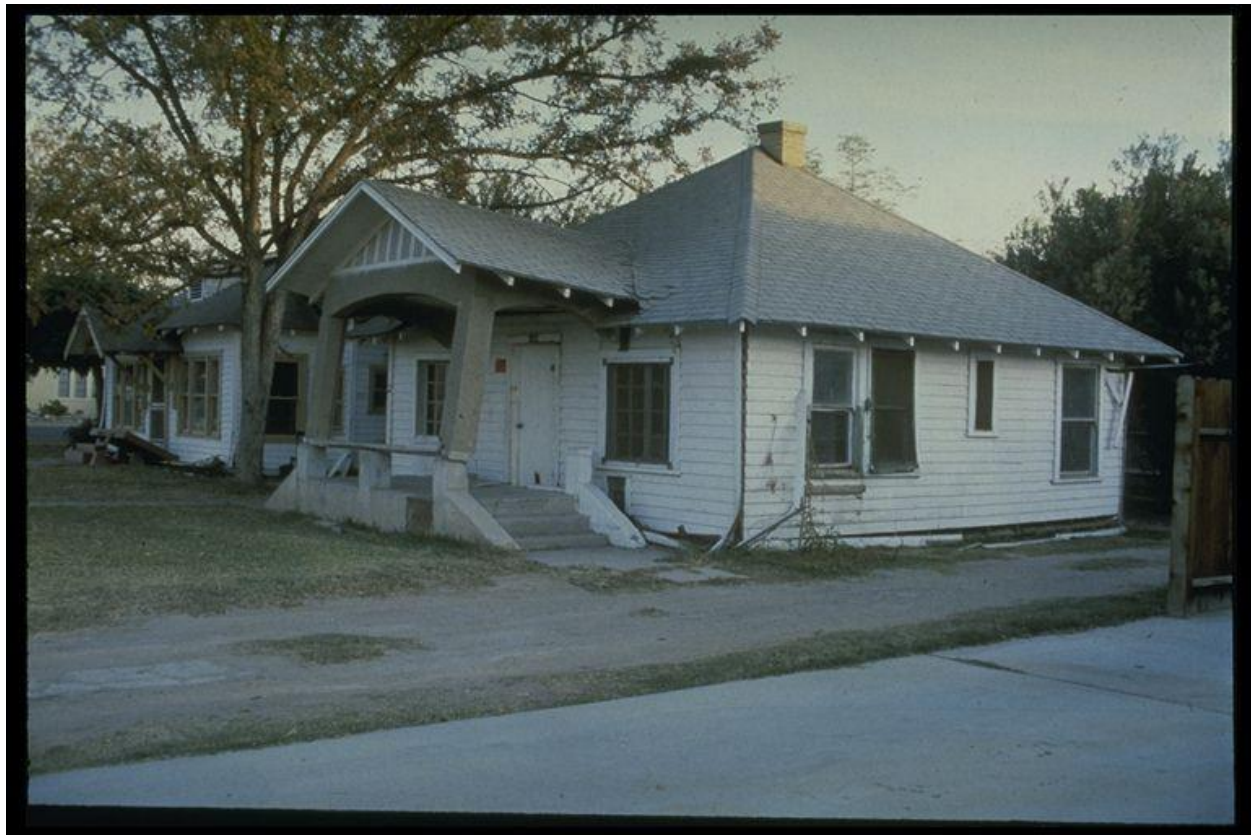
By inspection, 0%.

**Figure 3–2.** Image showing cripple wall collapse on a wood frame house in the 1979 Imperial Valley, California, earthquake.

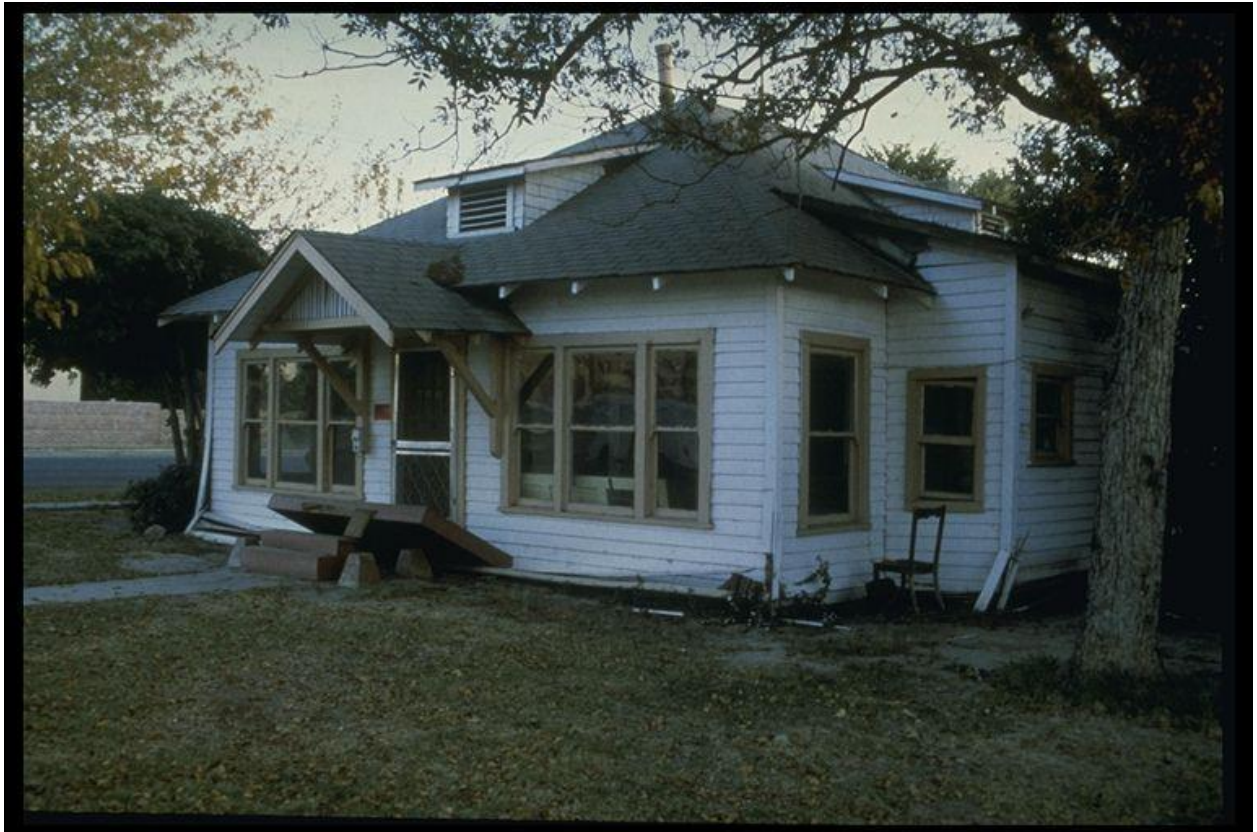
By inspection, 0%.

**Figure 3–3.** Image showing cripple wall collapse on a wood frame house in the 1979 Imperial Valley, California, earthquake.

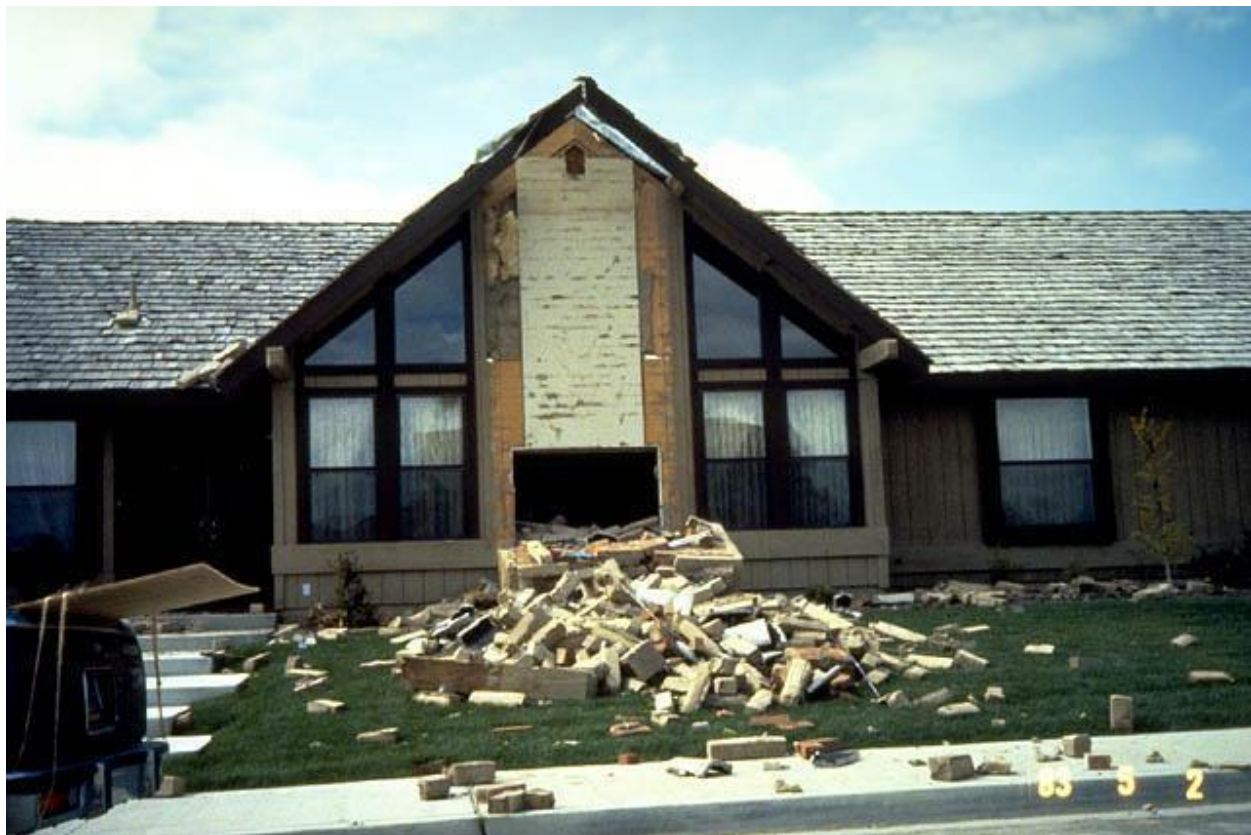
There are no other views of this building. Typical single-family dwelling is approximately 1,500 ft<sup>2</sup>, but this one looks a little larger, say 50% larger or 2,250 ft<sup>2</sup>. Bricks litter an area approximately 20 ft × 10 ft = 200 ft<sup>2</sup>, or 9%.

**Figure 5–2.** Image showing chimney collapse of a modern house in the 1983 Coalinga, California, earthquake.
