SESM 16-03

**An Earthquake Urban Search and  
Rescue Model Illustrated with a  
Hypothetical  $M_w$  7.0 Earthquake on the  
Hayward Fault**

**Keith A. Porter**

July 2016

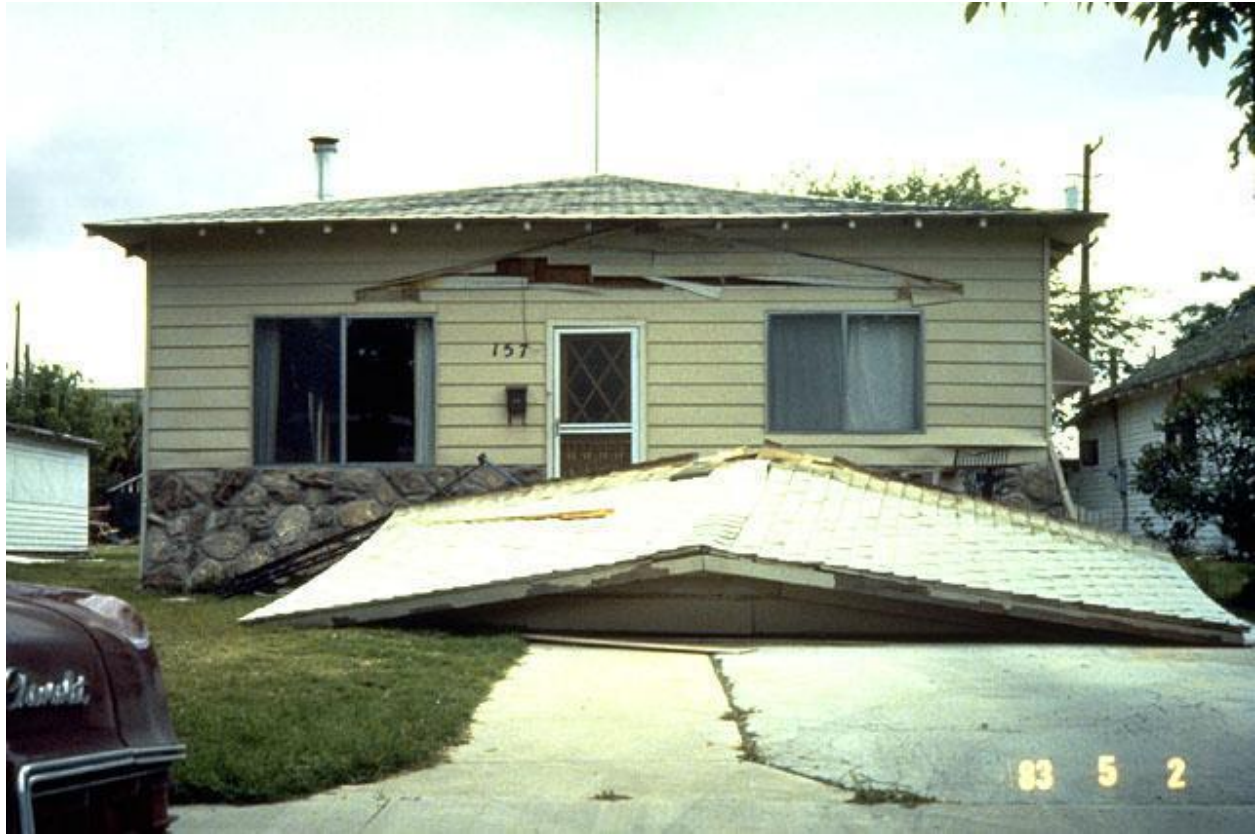
This porch appears to have measured 12 ft × 20 ft, so 200 ft<sup>2</sup> / 1,500 ft<sup>2</sup> ≈ 15%.

Figure 5-3. Image showing collapse of a wooden porch in the 1983 Coalinga, California, earthquake.

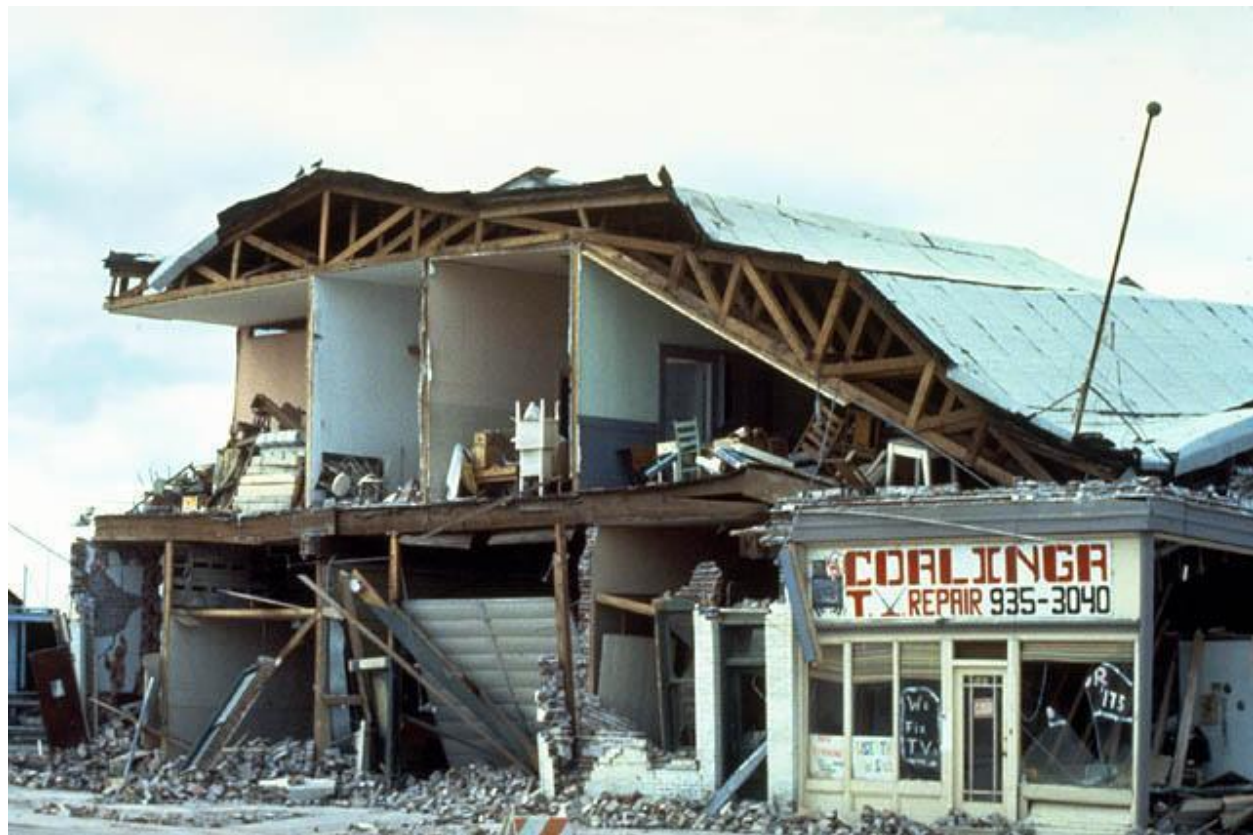
There are no other views of this building. It looks as if about half of the upper story of a two-story building collapsed (25%), plus bricks litter the perimeter, so say 30%.

**Figure 5–4.** Image showing collapse of an unreinforced brick building in the 1983 Coalinga, California, earthquake.

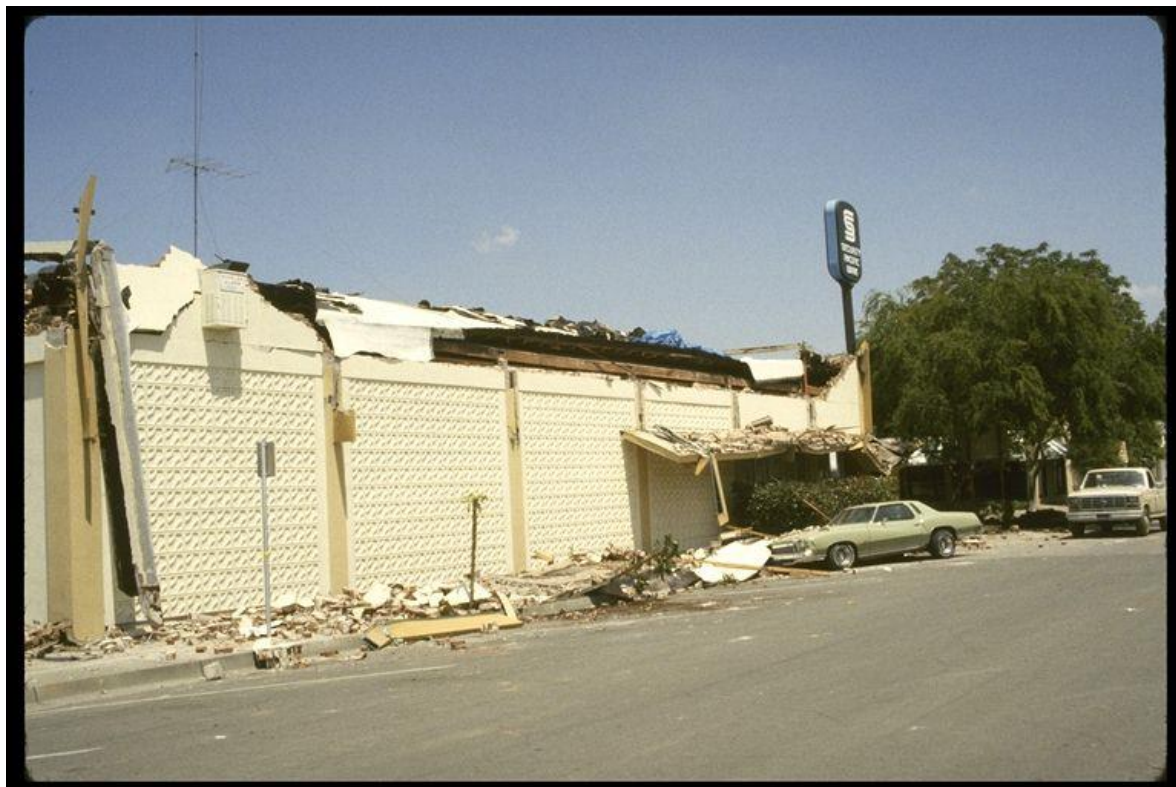
Building was at E. Durian Avenue and Coalinga Plaza, Coalinga, Calif. (<https://goo.gl/xddM2R>), possibly 286 Coalinga Plaza. No old satellite imagery. No estimate of plan area. No estimate of effected area.

**Figure 5–8.** Image showing parapet damage to a building in downtown Coalinga in the 1983 Coalinga, California, earthquake.

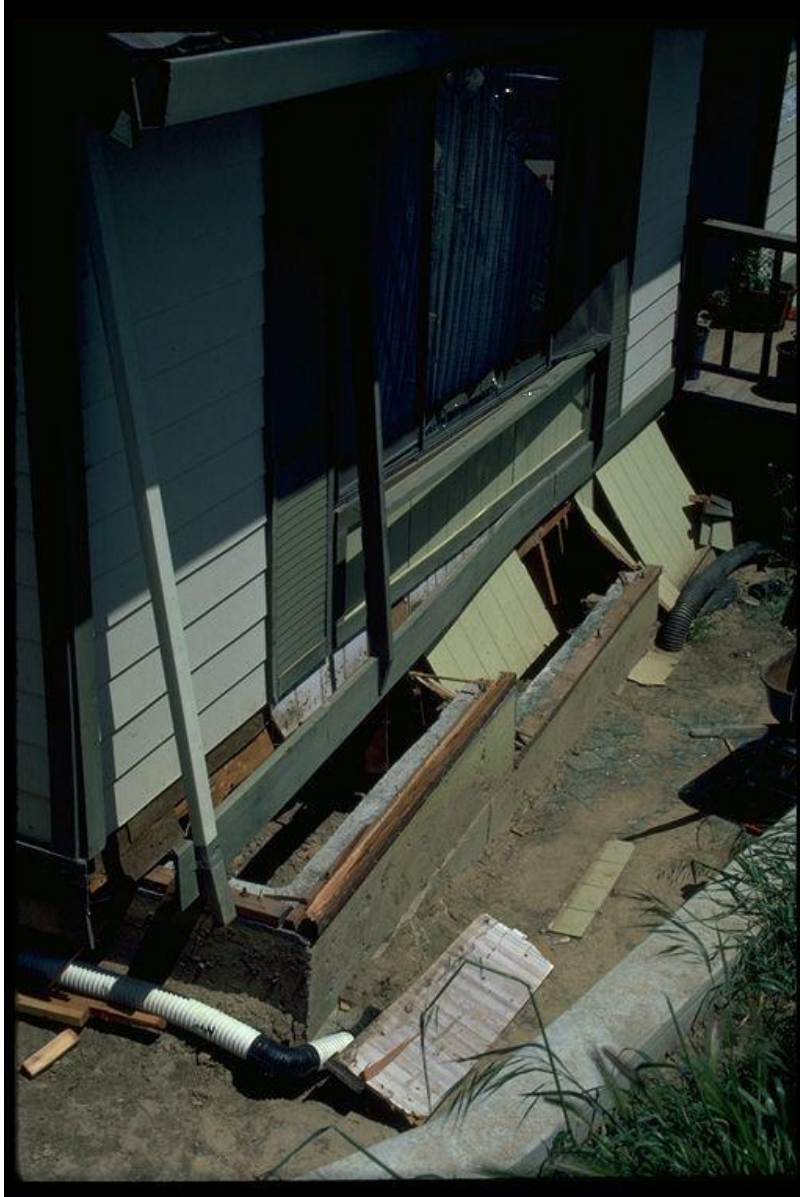
By inspection, 0%.

**Figure 6-1.** Image showing the most severely damaged dwelling in the 1984 Morgan Hill, California, earthquake.

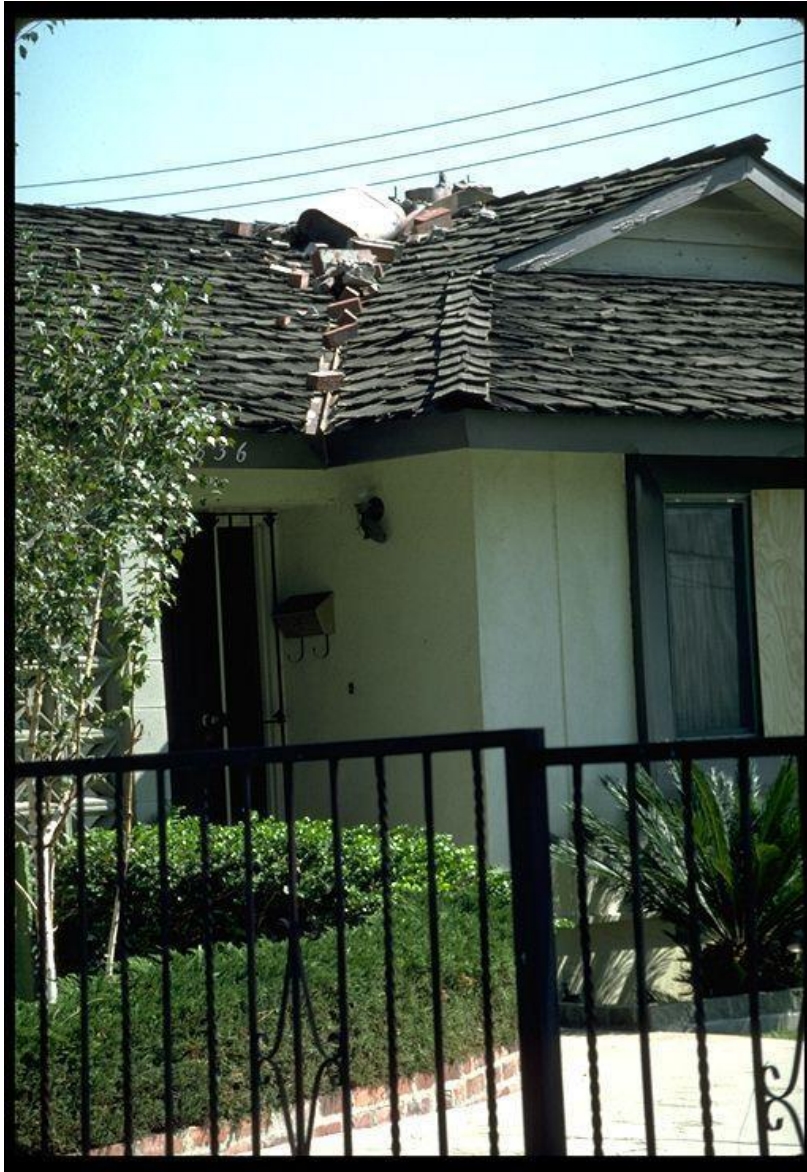
By inspection, 0%.

**Figure 7-1.** Image showing damage to roof from collapsed chimney in the 1987 Whittier Narrows, California, earthquake.

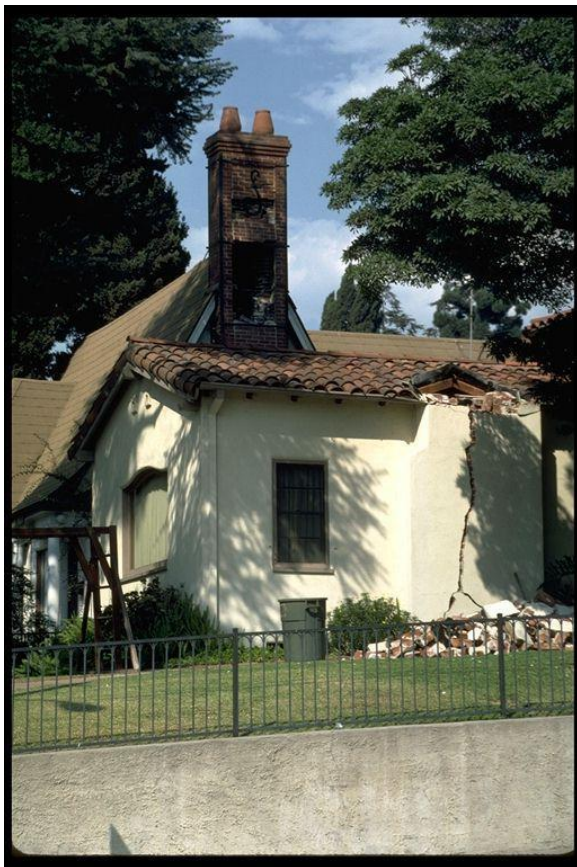
Assume typical plan area for single-family dwelling of 1,500 ft<sup>2</sup>. Bricks litter an area approximately 5 ft × 10 ft = 3%.

**Figure 7-4.** Image showing chimney damage in the 1987 Whittier Narrows, California, earthquake.

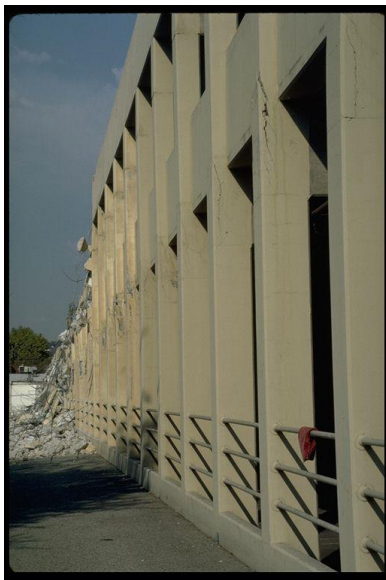
**Figure 7–5.** Image showing failure of parking structure roof in the 1987 Whittier Narrows, California, earthquake.

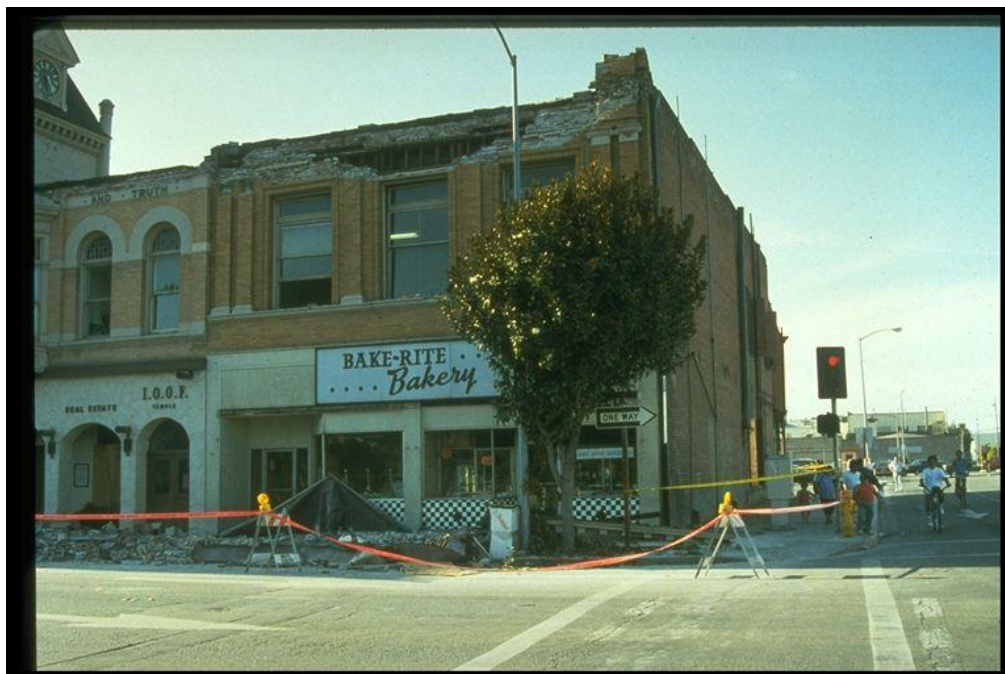
**Figure 8-2.** Image showing parapet and wall failures in Watsonville in the 1989 Loma Prieta, California, earthquake.

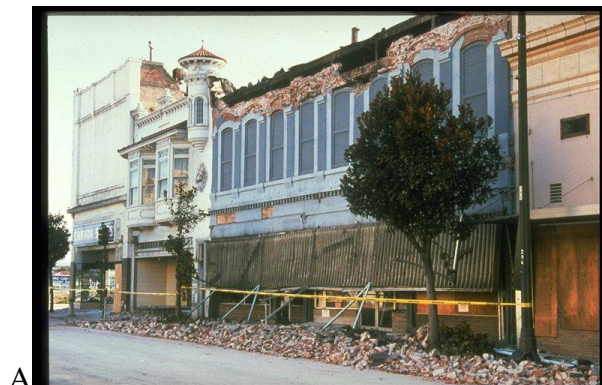
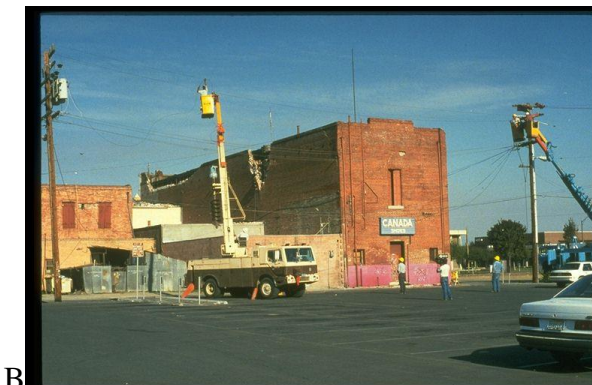
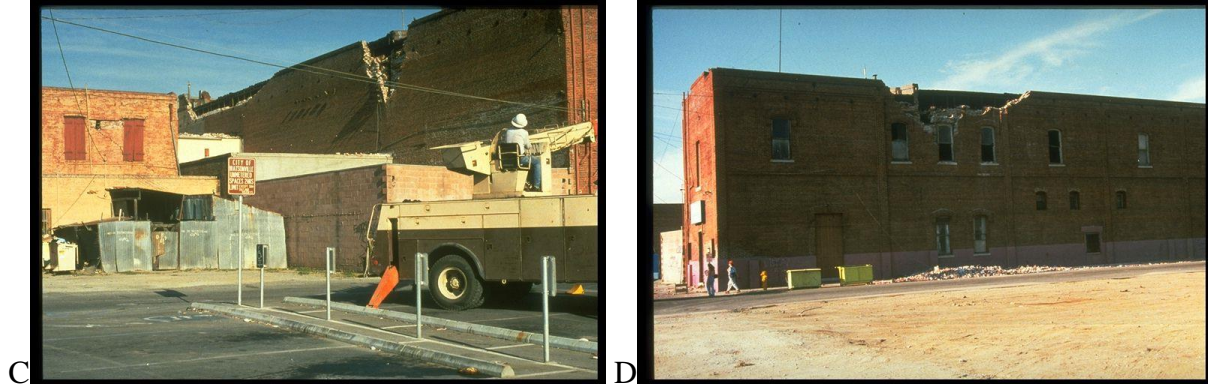
**Figure 8-3.** Images showing failed parapets in Watsonville the 1989 Loma Prieta, California, earthquake: *A* The building at the far left is 307 Main Street; the building in the foreground is 311 Main Street. *B, C, D:* three views of the sides and rear of 307 Main Street

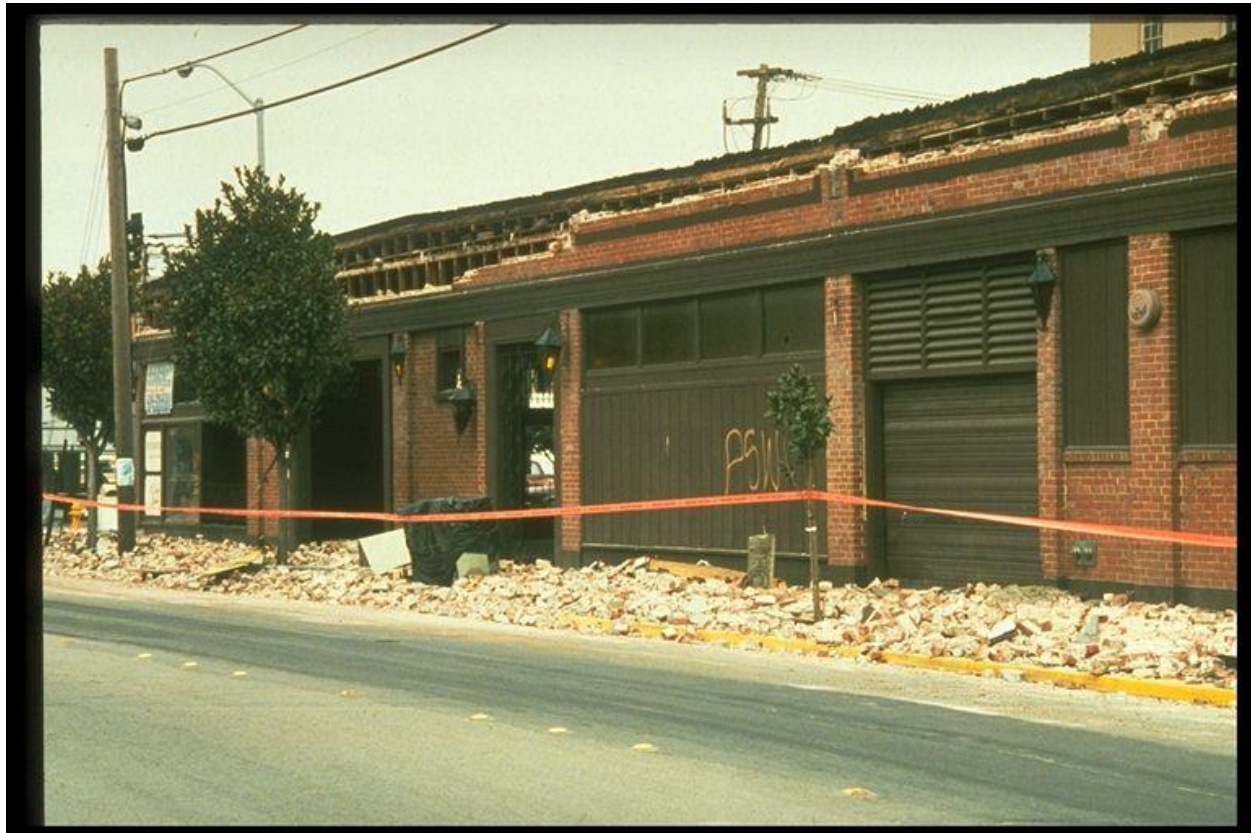
**Figure 8-4.** Image showing failed brick parapet fallen onto sidewalk in Watsonville in the 1989 Loma Prieta, California, earthquake.

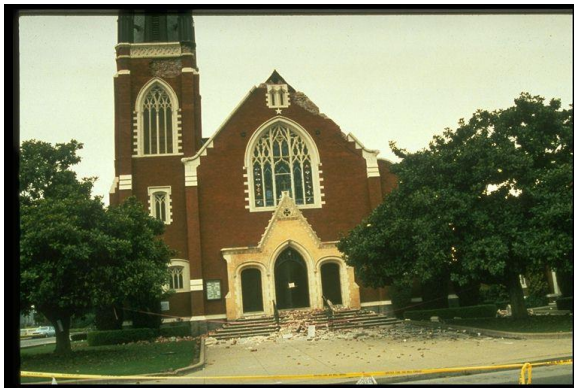
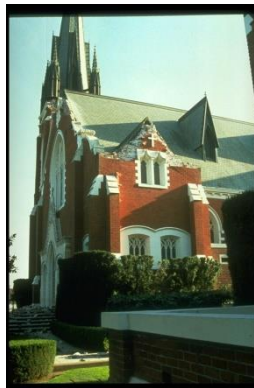
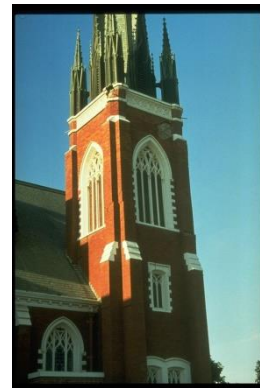
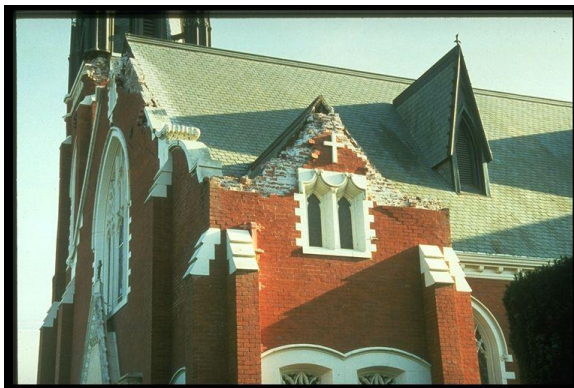
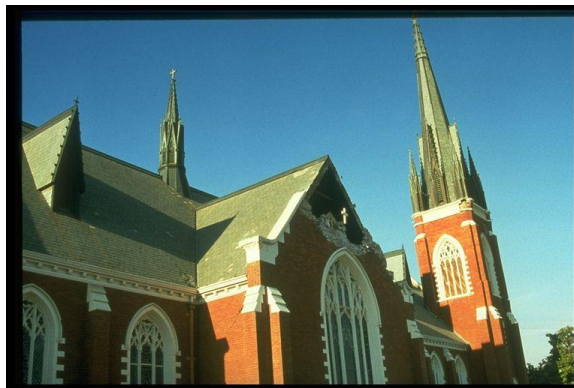
**Figure 8–5.** Images showing damage to St. Patrick’s Church, Watsonville, in the 1989 Loma Prieta, California, earthquake.

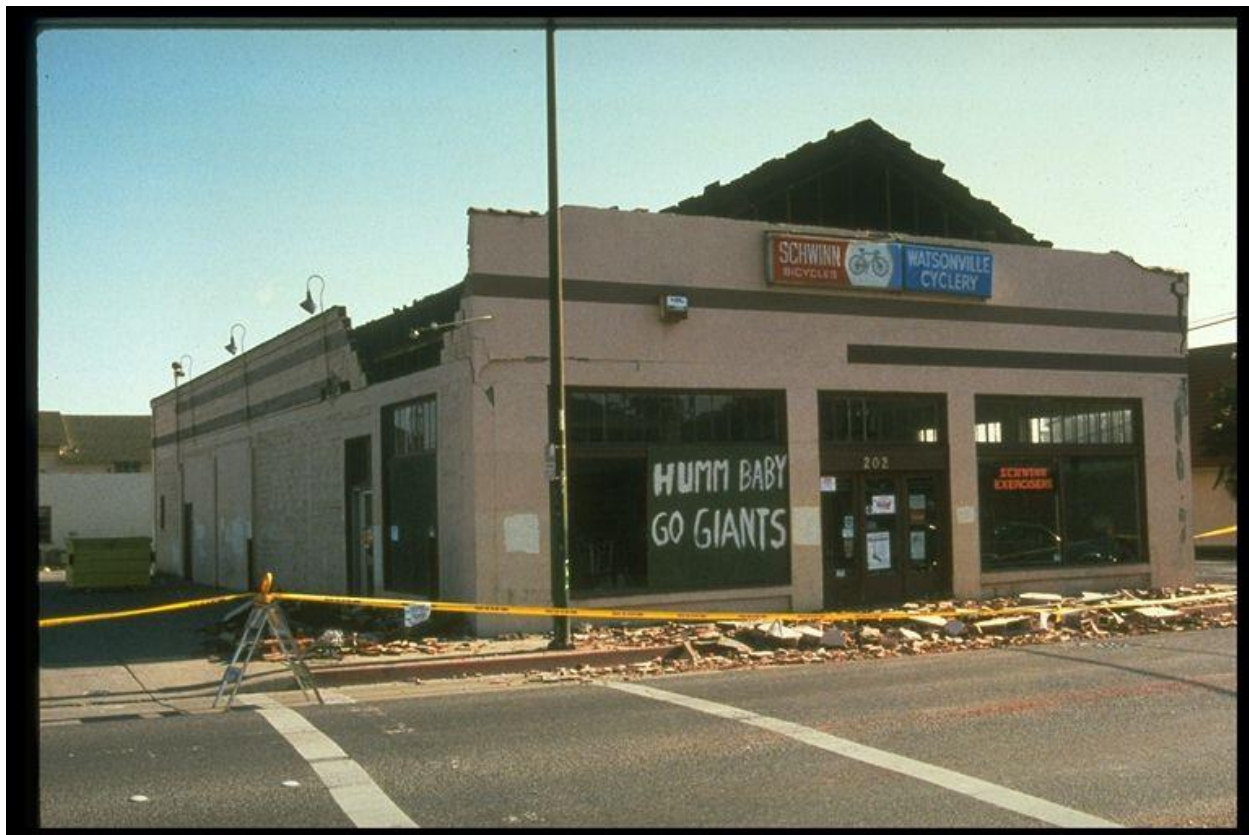
**Figure 8–6.** Image showing damaged bike store in Watsonville with failed parapet in the 1989 Loma Prieta, California, earthquake.

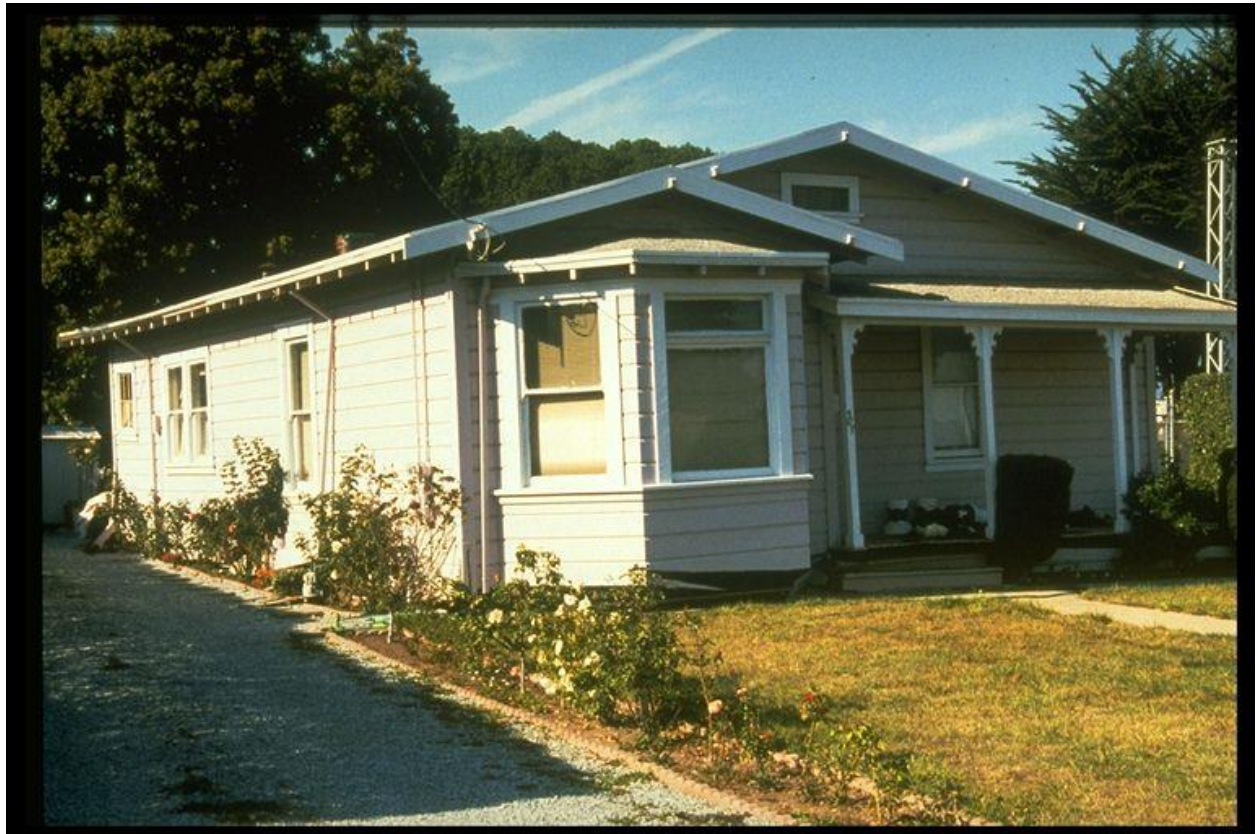
By inspection, 0%.

**Figure 8–7.** Image showing house with failed foundation in Watsonville in the 1989 Loma Prieta, California, earthquake.

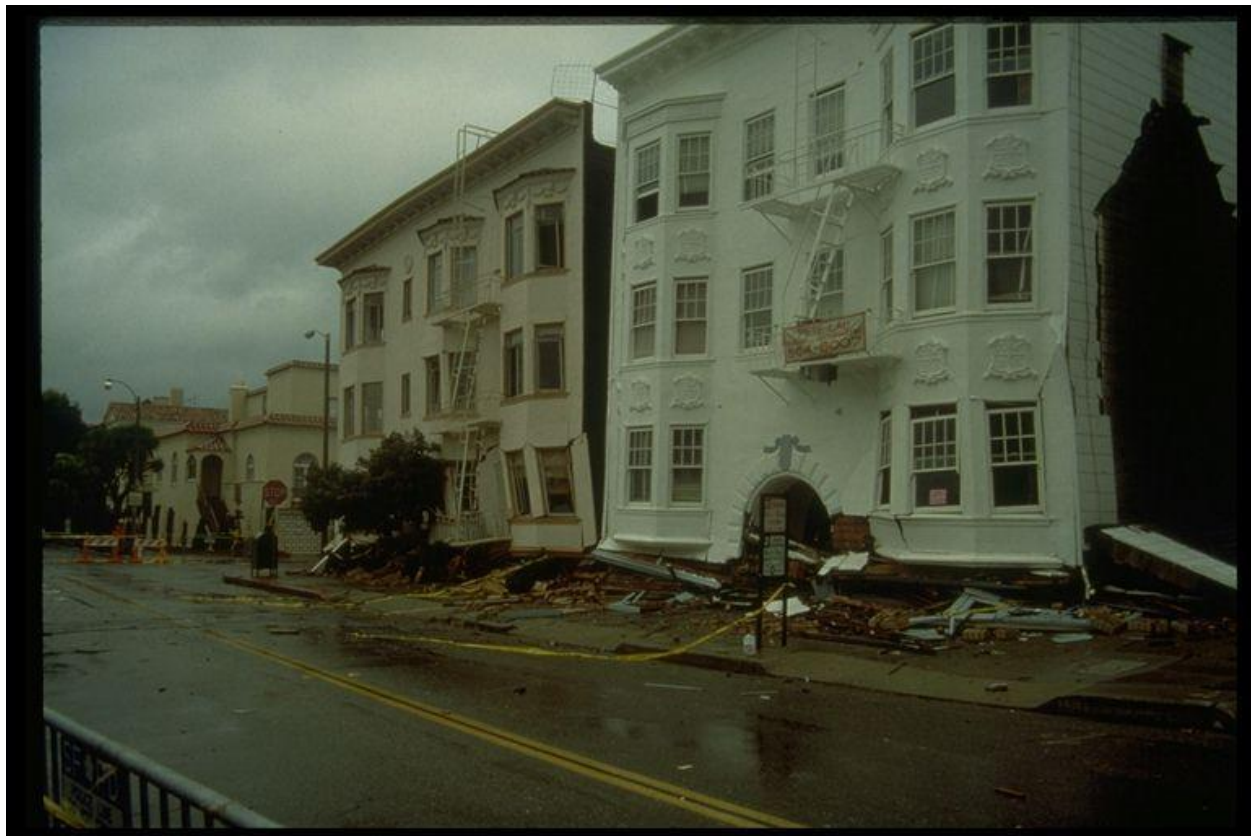
**Figure 8–10.** Image showing collapse of apartment buildings with soft ground floors in the Marina District of San Francisco in the 1989 Loma Prieta, California, earthquake.

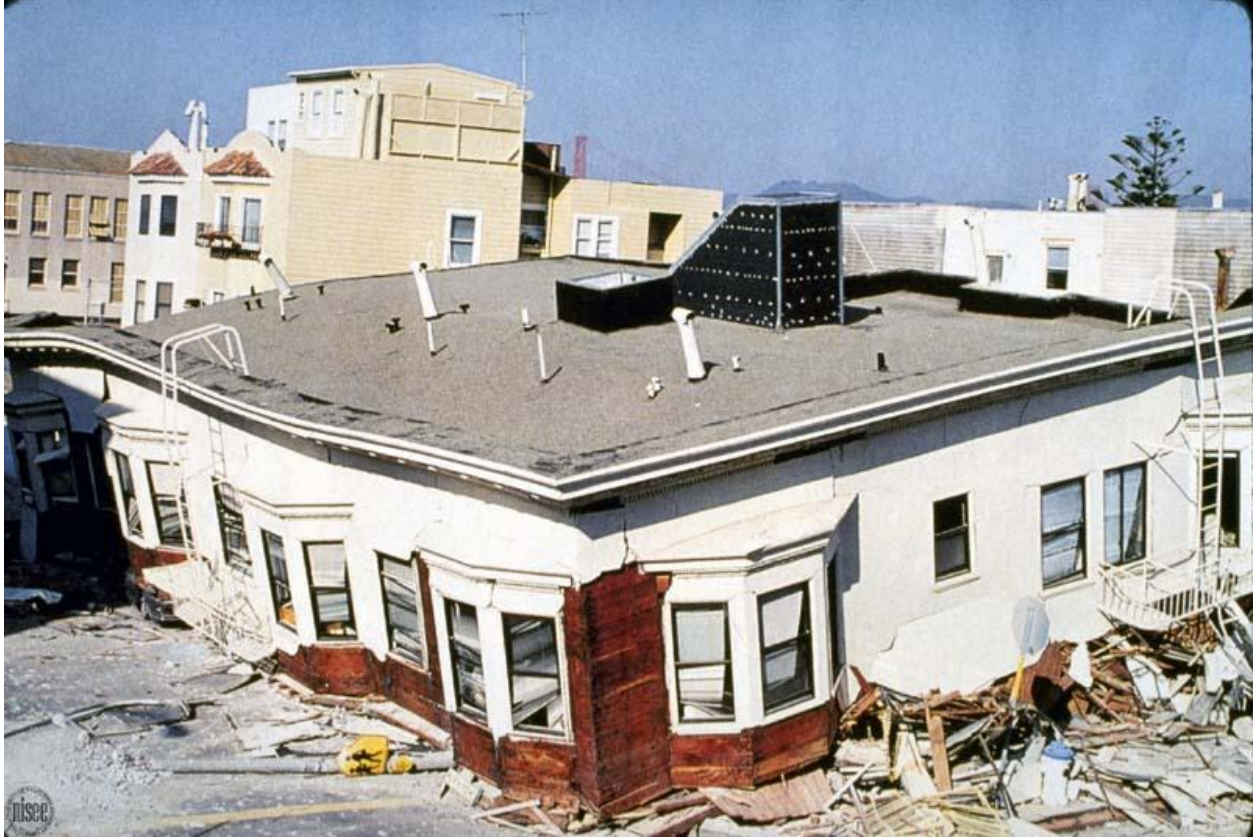
**Figure 8–12.** Image showing soft-story collapse of an apartment building in the Marina District, San Francisco, in the 1989 Loma Prieta, California, earthquake. Karl V. Steinbrugge Collection: S6144, copyright restricted.

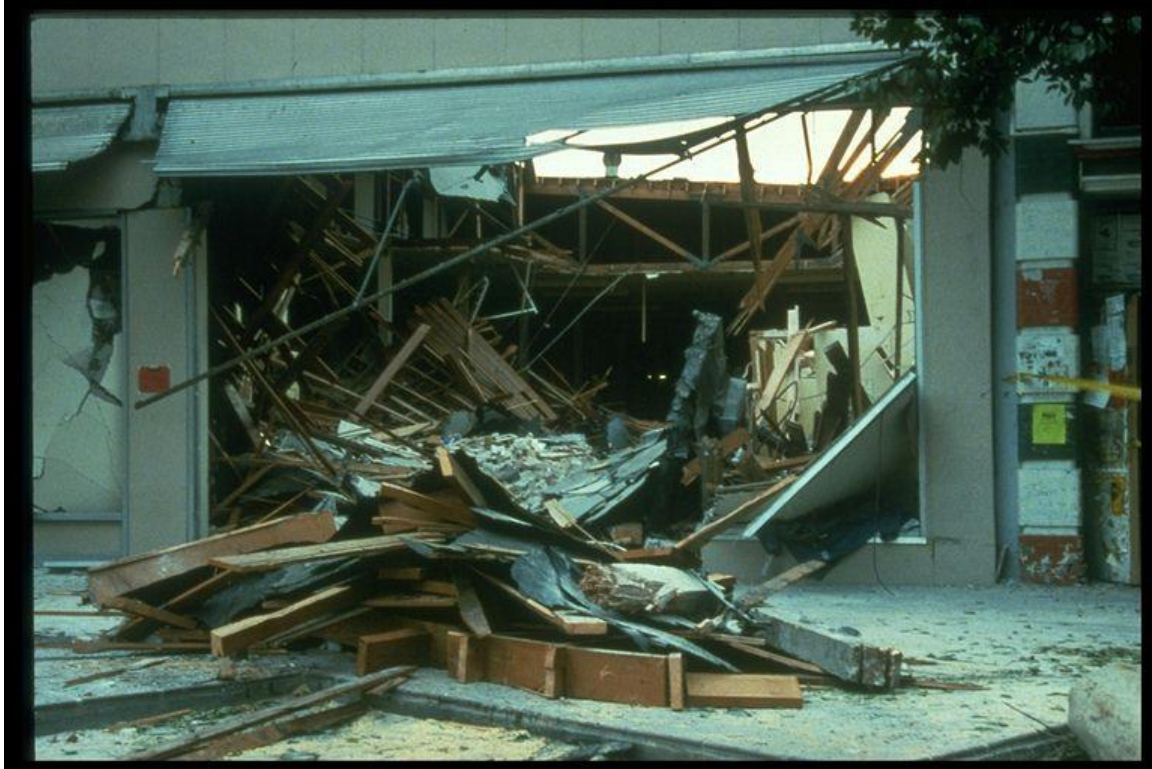
**Figure 8–14.** Image showing interior structural failure in a department store in Santa Cruz in the 1989 Loma Prieta, California, earthquake.

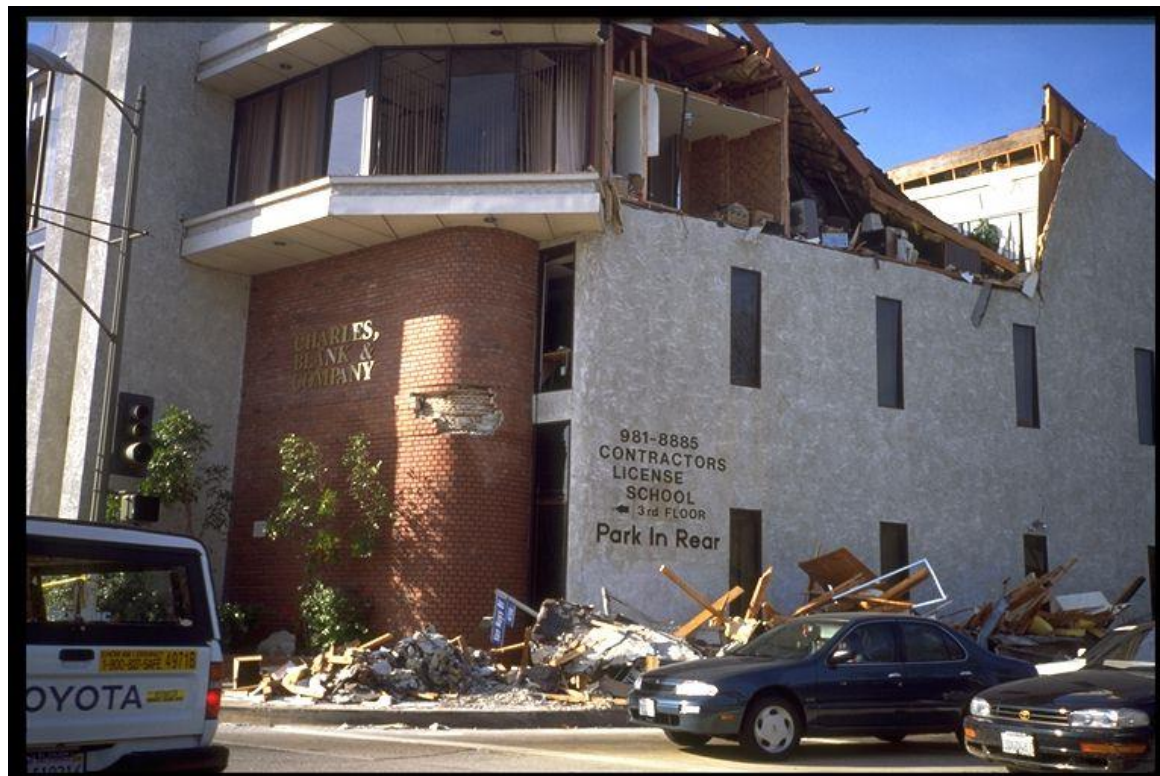
**Figure 9–3.** Image showing building components fallen onto off-ramp in the 1994 Northridge, California, earthquake.

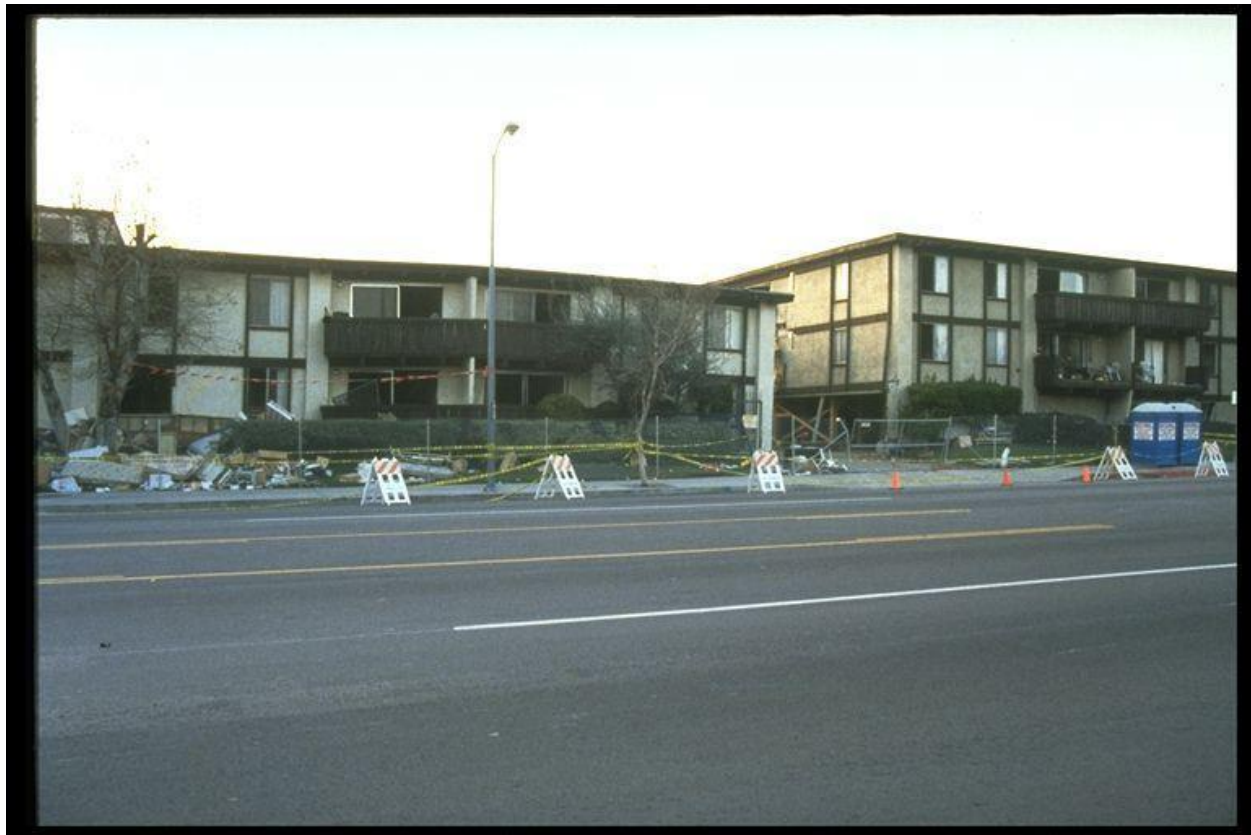
**Figure 9-4.** Image showing collapse of ground story at Northridge Meadows Apartments in the 1994 Northridge, California, earthquake.

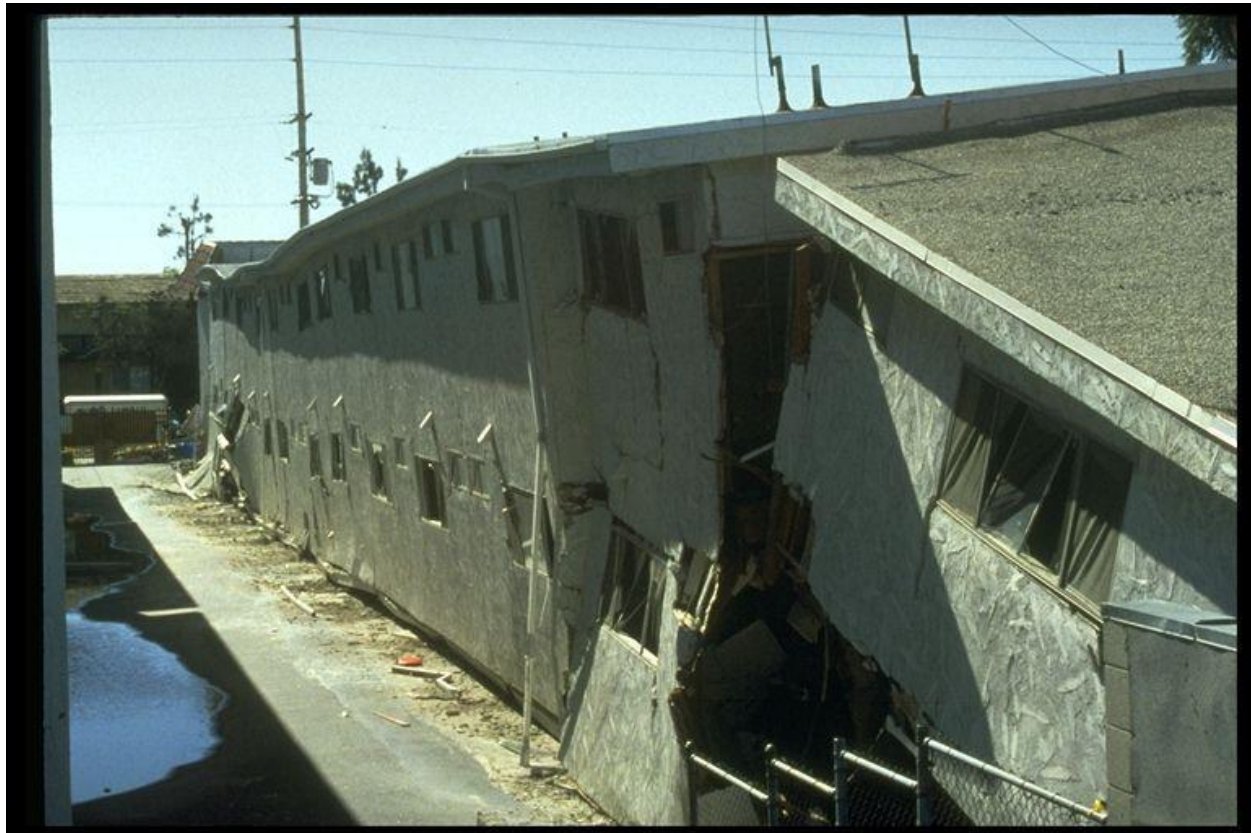
**Figure 9-5.** Image showing collapse of ground story at Northridge Meadows Apartments in the 1994 Northridge, California, earthquake.

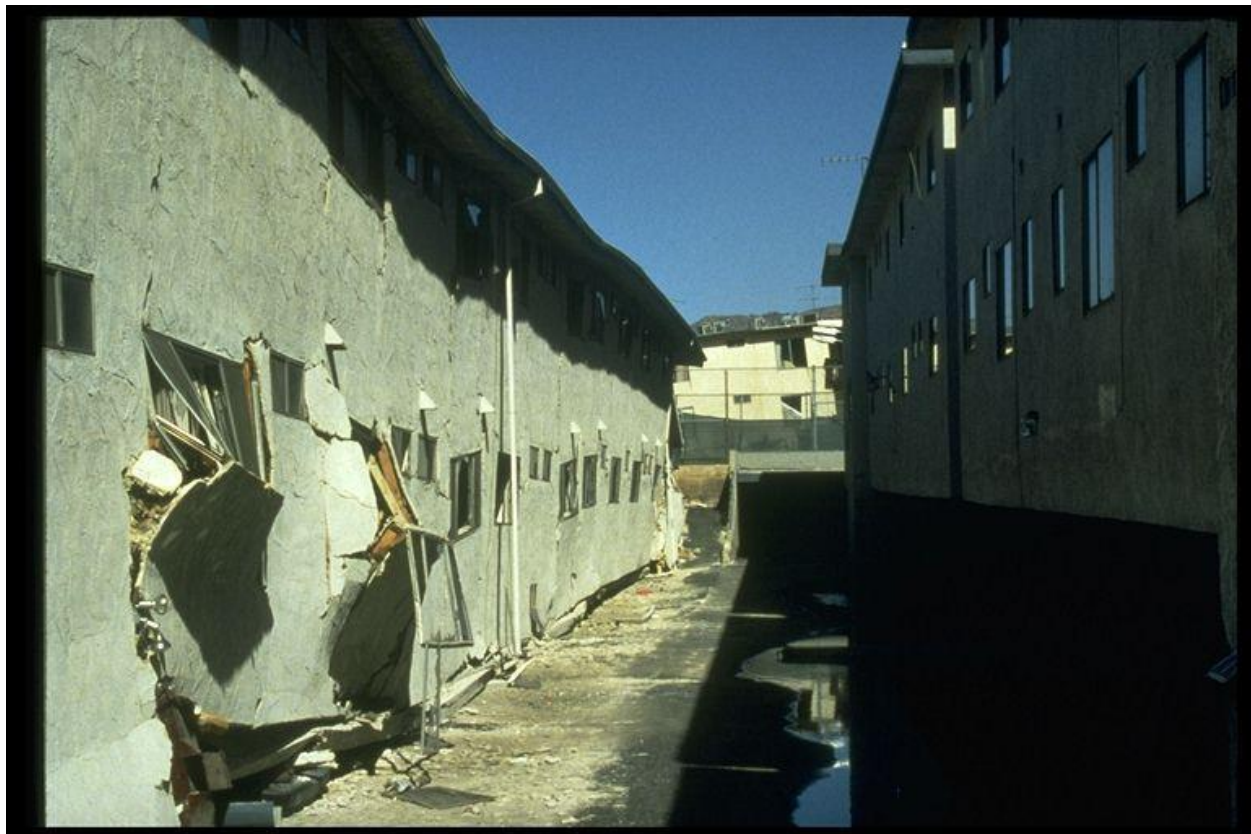
**Figure 9-6.** Image showing collapse of ground story at Northridge Meadows Apartments in the 1994 Northridge, California, earthquake.

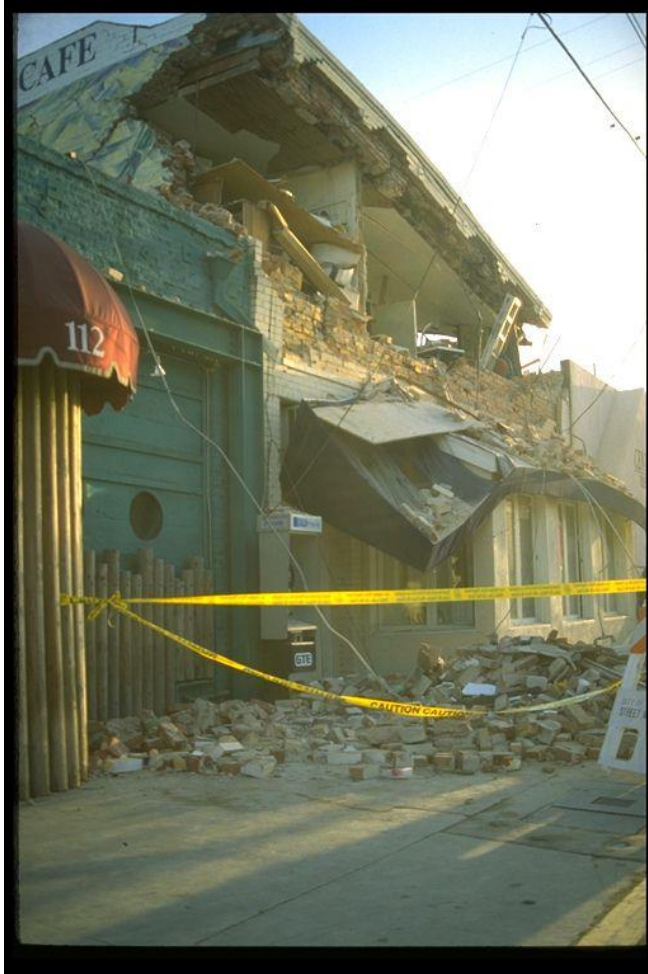
**Figure 9-7.** Image showing damage to two-story masonry building in Santa Monica in the 1994 Northridge, California, earthquake.

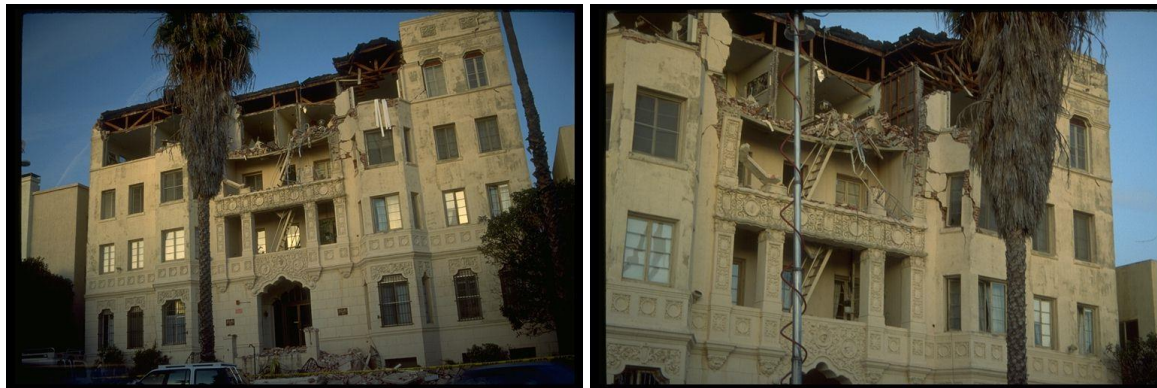
**Figure 9–8.** Image showing damage to four-story masonry building in Santa Monica in the 1994 Northridge, California, earthquake.

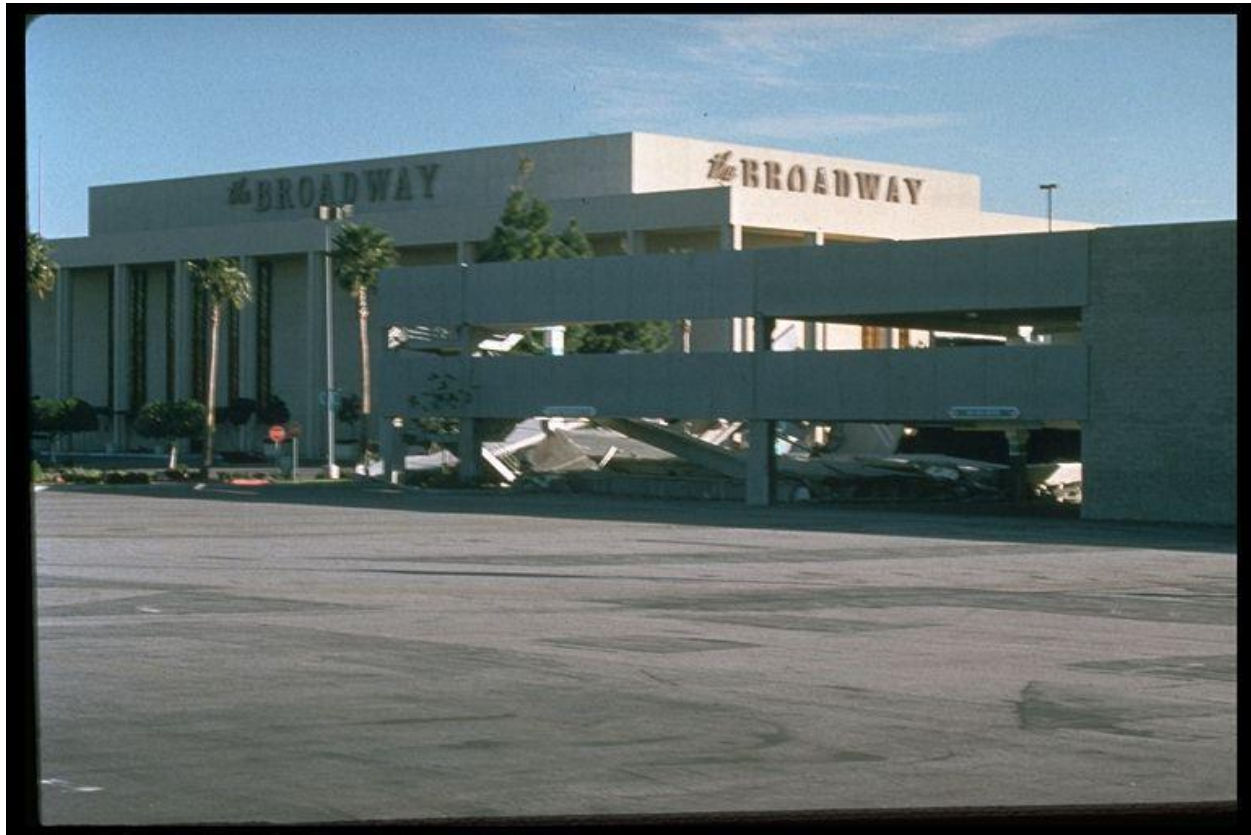
**Figure 9–12.** Image showing collapse of floors in the Northridge Fashion Center parking garage in the 1994 Northridge, California, earthquake.

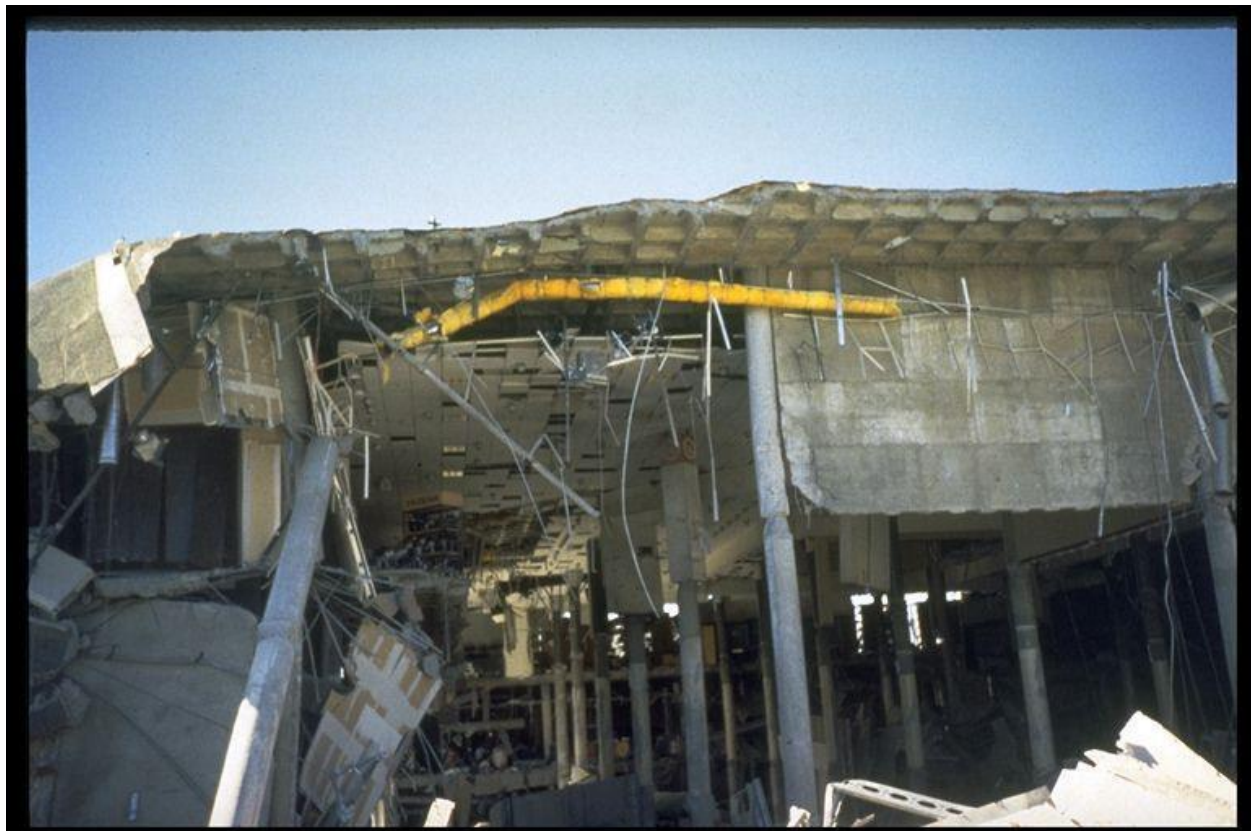
**Figure 9–13.** Image showing collapse of second- and third-floor concrete waffle slabs at Bullock’s retail store in the 1994 Northridge, California, earthquake.
