SESM 16-03

**An Earthquake Urban Search and  
Rescue Model Illustrated with a  
Hypothetical  $M_w$  7.0 Earthquake on the  
Hayward Fault**

**Keith A. Porter**

July 2016

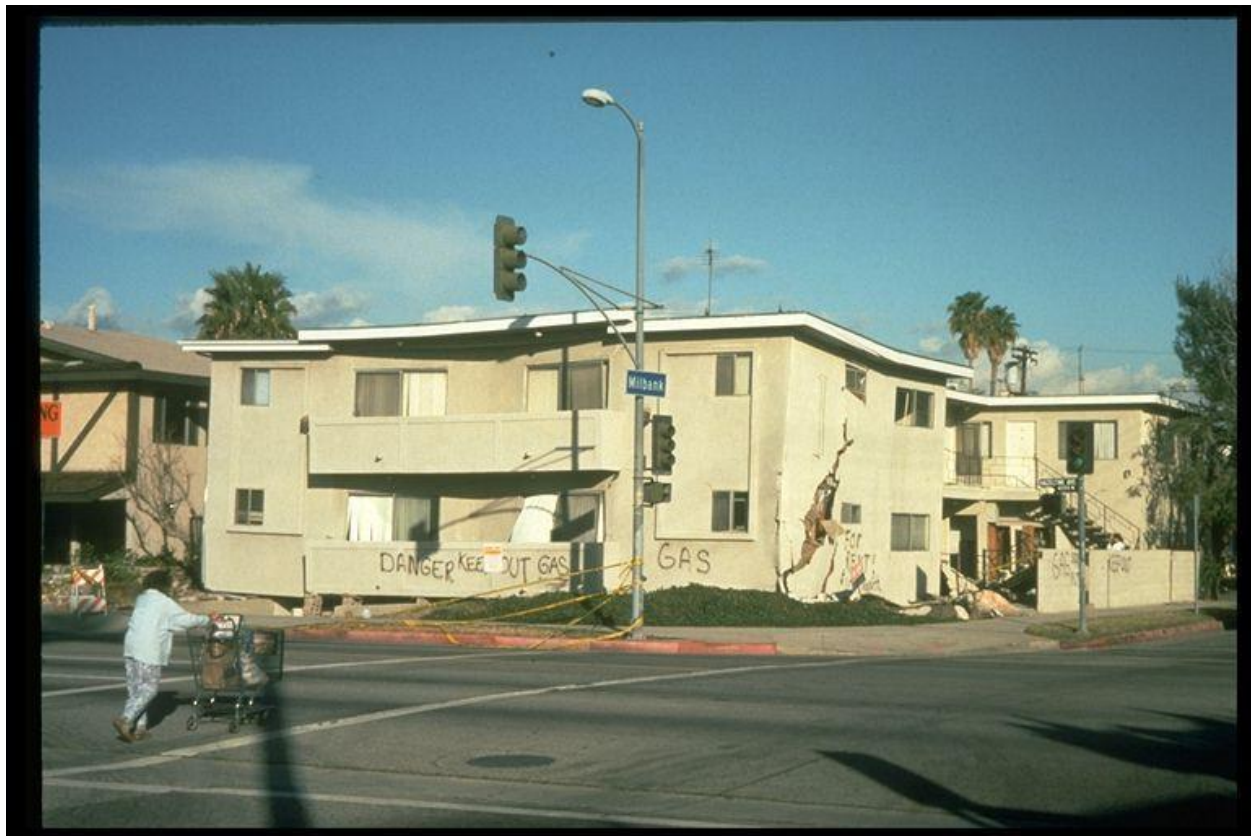
**Figure 9–16.** Image showing soft-story collapse of apartment building in Sherman Oaks in the 1994 Northridge, California, earthquake.

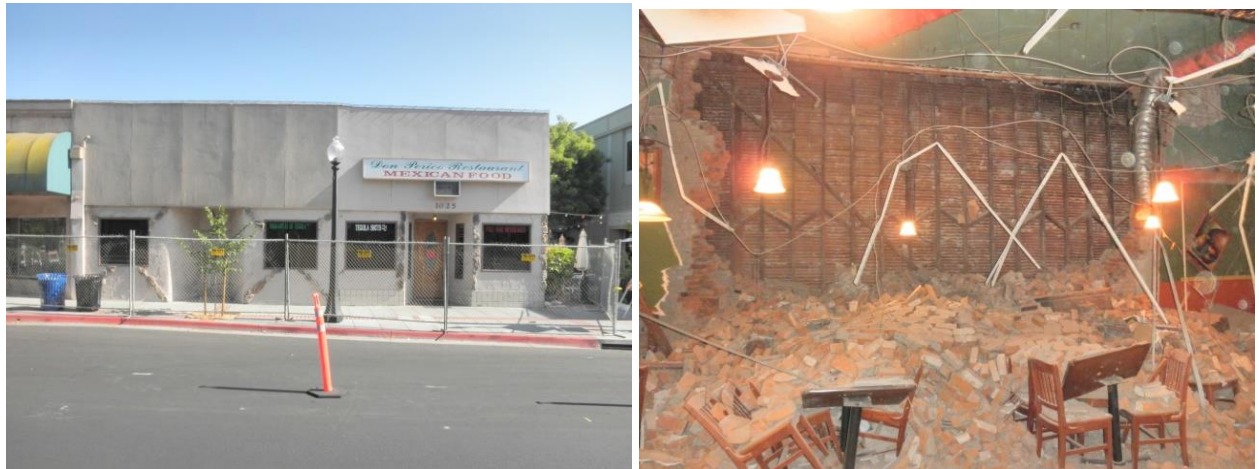
**Figure 11–1.** Image showing damage to Don Perico's Restaurant in Napa in the 2014 South Napa, California, earthquake.
