# Using Artificial Intelligence for Roof Fall Hazard Identification in Limestone Mines

# Ergin Isleyen

# Advisors: Dr. Sebnem Duzgun, Dr. McKell Carter

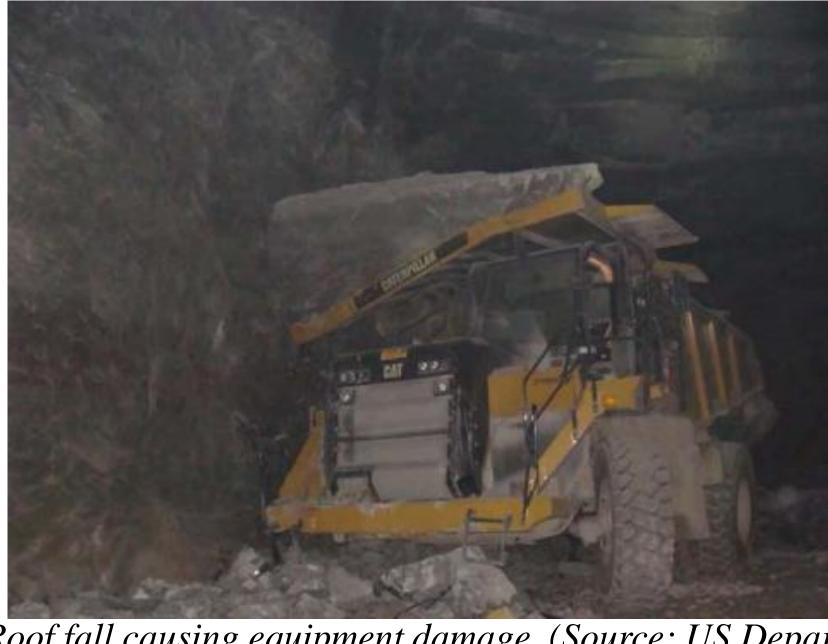
Figure: Roof fall causing equipment damage. (Source: US Department of Labor)

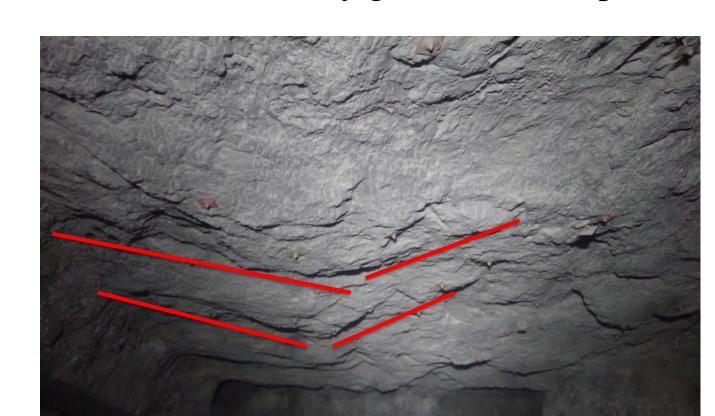
Figure: V-shaped features on the mine roof

- Roof hazard conditions are assessed by visual inspections and knowledge gained through observational techniques. Near-failures are usually detected by sounding.
- V-shaped features caused by high horizontal stresses on the mine roof are used as indicators of hazardous roof conditions by ground control personnel at the mine.

- Smoother roof surfaces are observed where the roof conditions are non-hazardous.
- Experts stated that they use **depth** and **frequency** of the V-shaped features to determine the hazard level.
- Image data has a promising potential in developing an autonomous hazard detection system since the current roof fall hazard assessment techniques depend on visual clues.
- Development of a convolutional neural network system that classifies roof fall hazard levels based on roof images is explained in this poster.

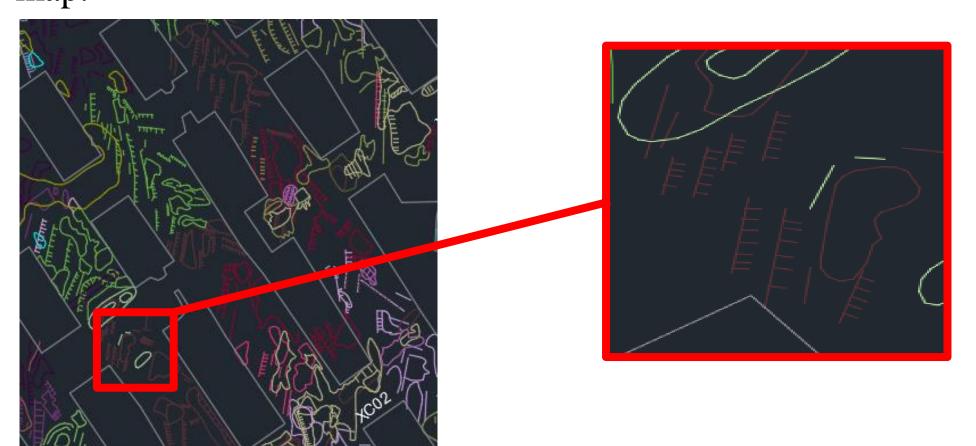
• Ground control personnel kept records of V-shaped features and drew them on the mine

Relationship between V-shaped features and previous roof falls is shown by using the mapped features around previous roof fall locations and randomly selected non-roof fall locations.

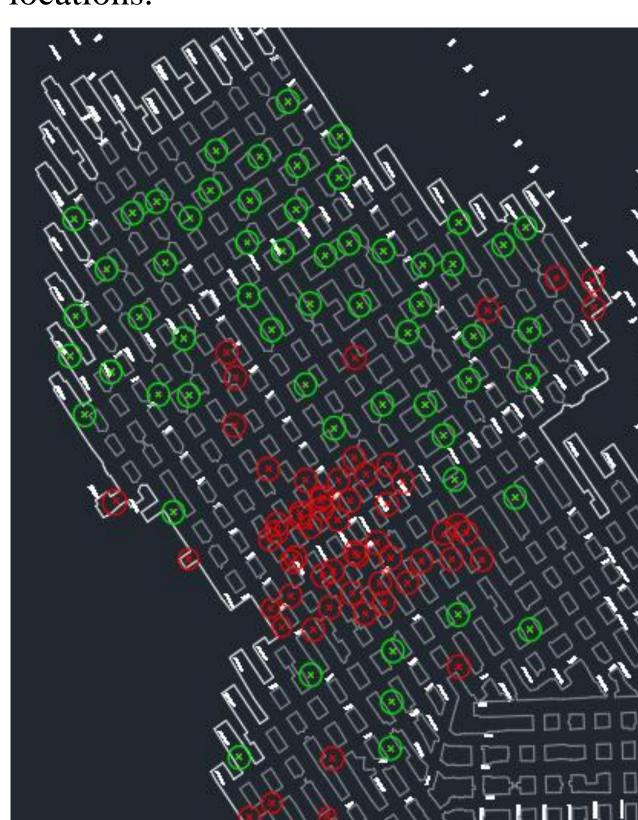
• A circle with a radius of 30 ft is drawn around each roof fall and no roof fall location. Number of chevron features inside each circle and the average depth of the features inside each circle were recorded.

Frequency	Depth
P-Values	0.00006	0.02

• The difference between V-shaped features (frequency and depth) around roof fall locations and V-shaped features around no-roof fall locations is unlikely to occur by chance. It is therefore plausible that the frequency and depth of V-shaped features could be used as indicators of a roof fall hazard.

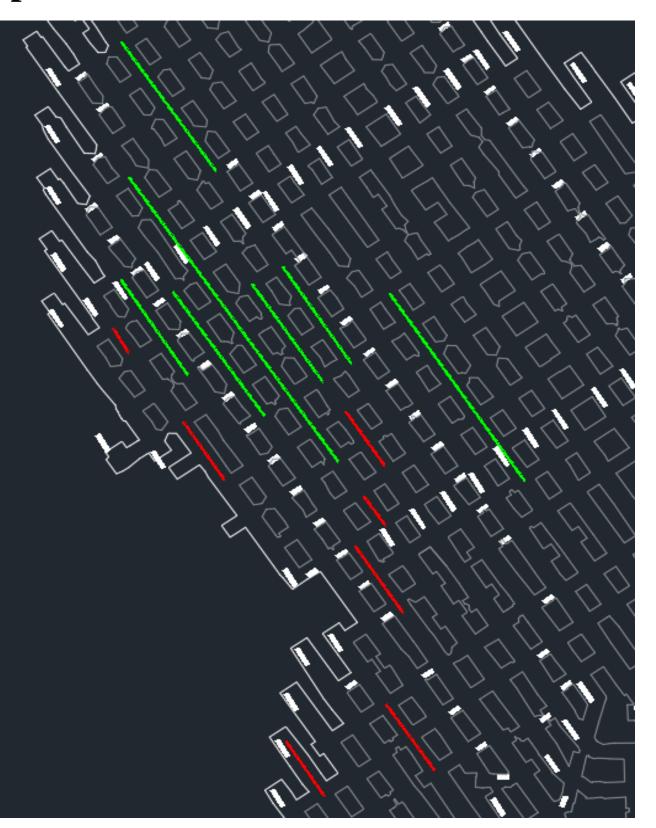
#### Hazardous Roof

Non-hazardous Roof

- Hazardous and non-hazardous roof locations are selected based discussions with ground control experts in the mine.
- The difference in hazard levels between selected hazardous and hazardous roof locations demonstrated by comparing the frequency and depth of V-shaped features.
- Using the mine map, the number and the average depth of the V-shaped features were recorded. A statistical t-test is done to see if there is a significant difference between selected hazardous and non-hazardous data collection locations.
- P-Values: Frequency: 0.0005, Depth: 0.016
- The difference between V-shaped features around expert-categorized hazardous and nonhazardous locations is statistically significant, confirming frequency and depth are related to human identified hazards.
- Images are obtained using a Nikon D5000 camera in the selected locations.
