SESM 16-03

**An Earthquake Urban Search and  
Rescue Model Illustrated with a  
Hypothetical  $M_w$  7.0 Earthquake on the  
Hayward Fault**

**Keith A. Porter**

July 2016

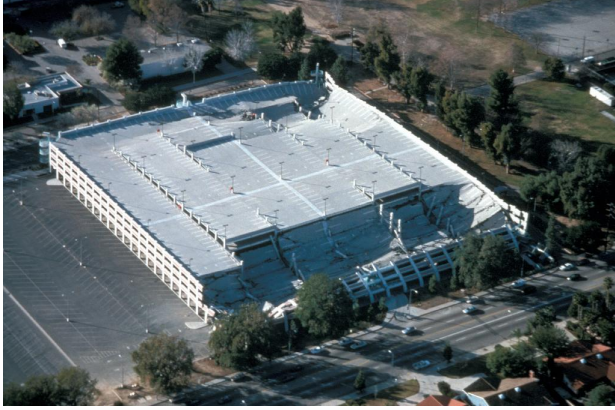
**Figure 9.** Example of a partially collapsed reinforced concrete structure: a parking structure at California State University, Northridge. Photo credit: P. Weigand. Permission for use granted per <http://goo.gl/tmht1n>.

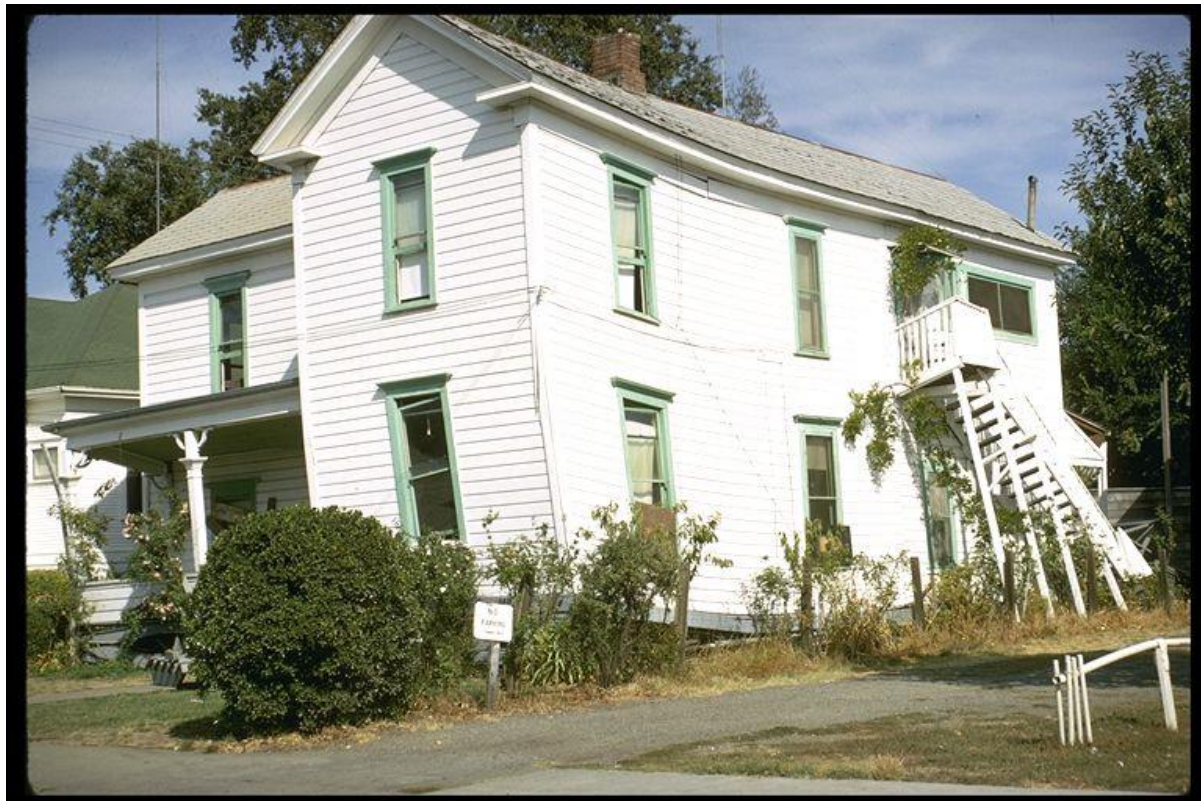
0%

**Figure 1-1.** Image showing two-story wood frame house collapsed in the 1969 Santa Rosa, California, earthquake.

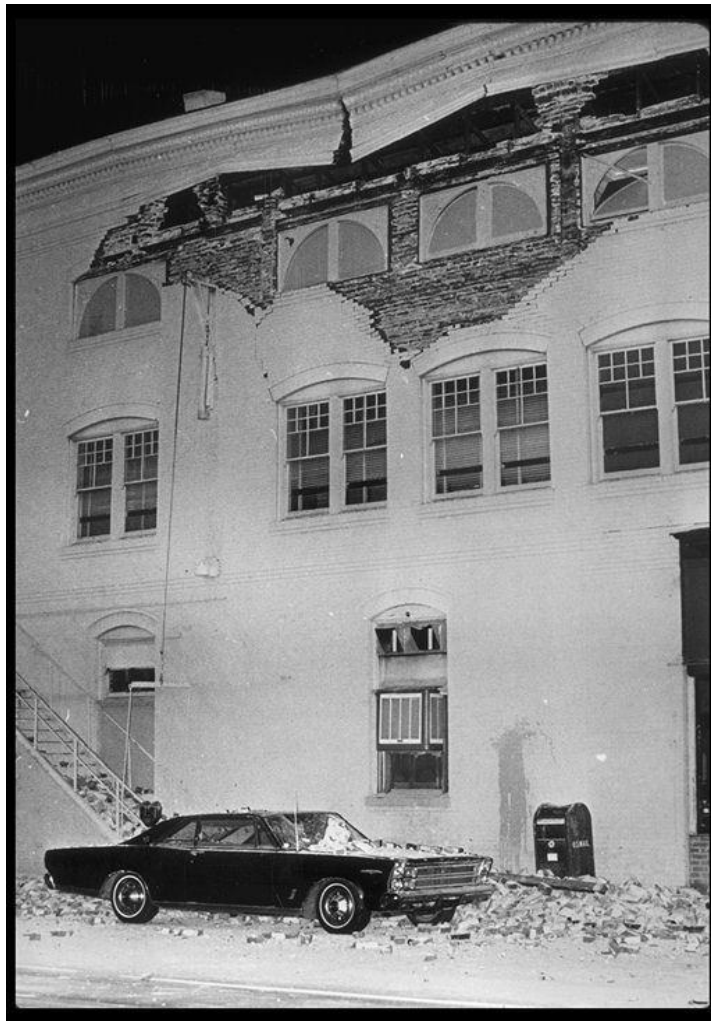
Plan area  $\approx 13,000 \text{ ft}^2 \times 3 \text{ stories}$ . Area littered by bricks  $\approx 25 \text{ ft} \times 15 \text{ ft} = 1\%$  of  $39,000 \text{ ft}^2$ .

Figure 1-2. Image showing part of a wall collapsed onto a car in the 1969 Santa Rosa, California, earthquake.

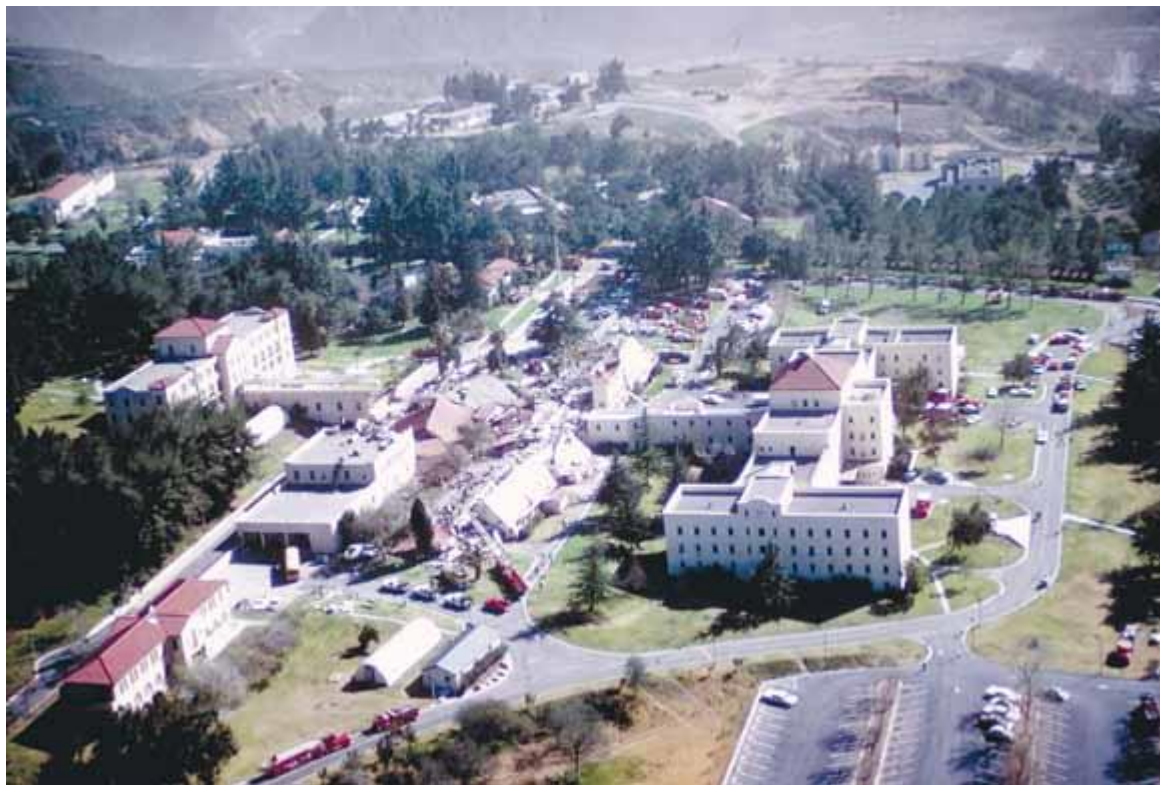
The view is from the west. The Semi-Ambulent Building was a long building oriented east to west, the second building from the south (that is, second from right), in the middle of the photo. Portions of the building are leaning at various angles to the north. The wing is a complete loss, but it appears as if it did not pancake. The estimate of 50% from NISEE S4195 seems reasonable.

**Figure 2–10.** Images showing four collapsed buildings at the San Fernando Veterans Administration Hospital complex in the 1971 San Fernando, California, earthquake.

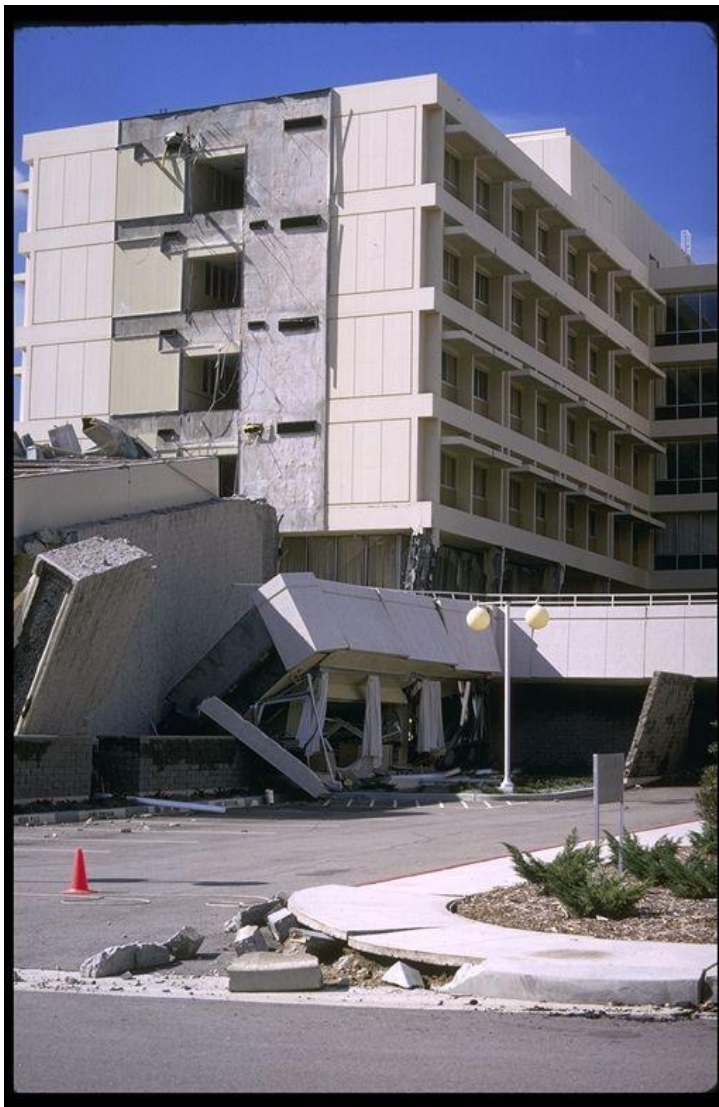
**Figure 2-12.** Image showing collapsed tower at Olive View Hospital, Sylmar, in the 1971 San Fernando, California, earthquake.

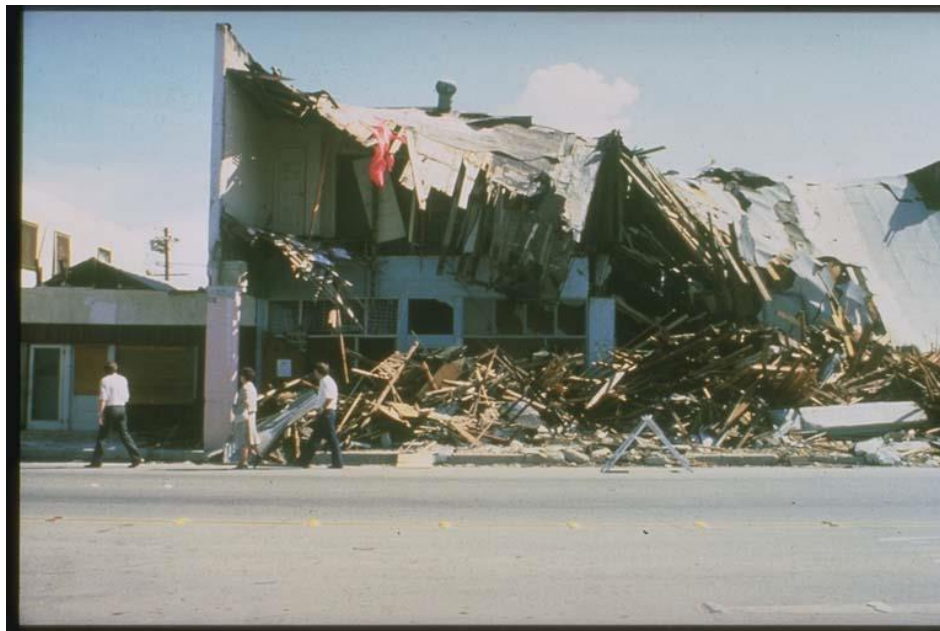
100%

**Figure 4-1.** View of a two-story building on West Main St, Westmorland after the April 26, 1981 Westmorland earthquake

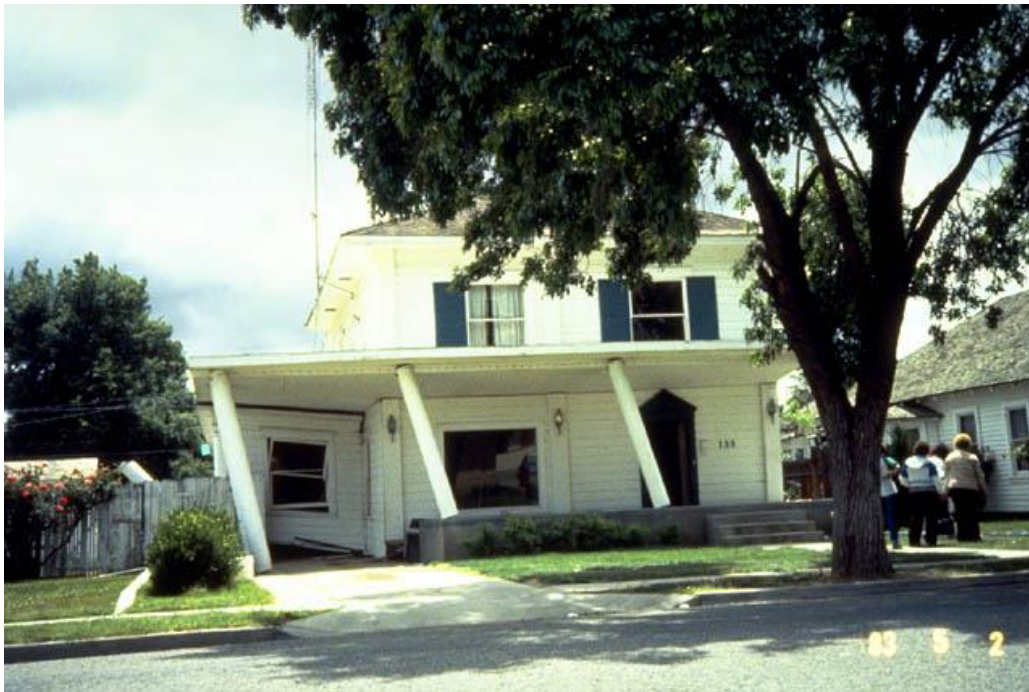
0%

**Figure 5-1.** Image showing lateral displacement of two-story wood frame dwelling in the 1983 Coalinga, California, earthquake.

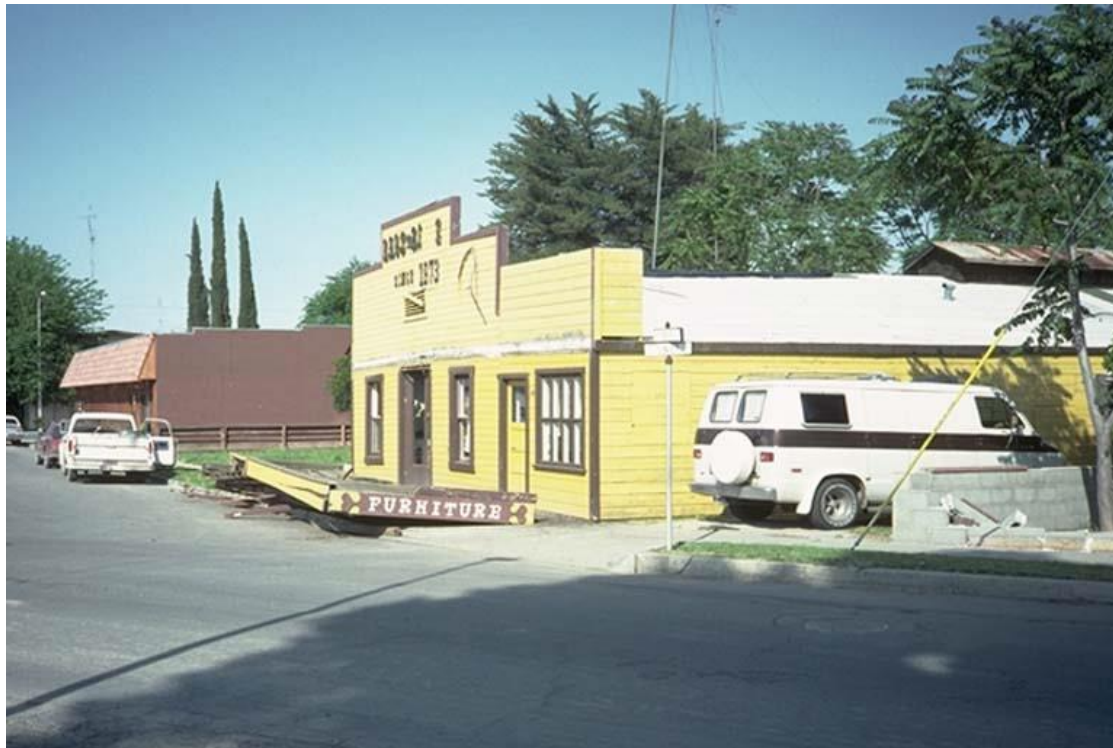
No long shot to show how long the building is. No address. No estimate of affected area.

**Figure 5-5.** Image showing a heavy wooden overhang fallen onto sidewalk in the 1983 Coalinga, California, earthquake.

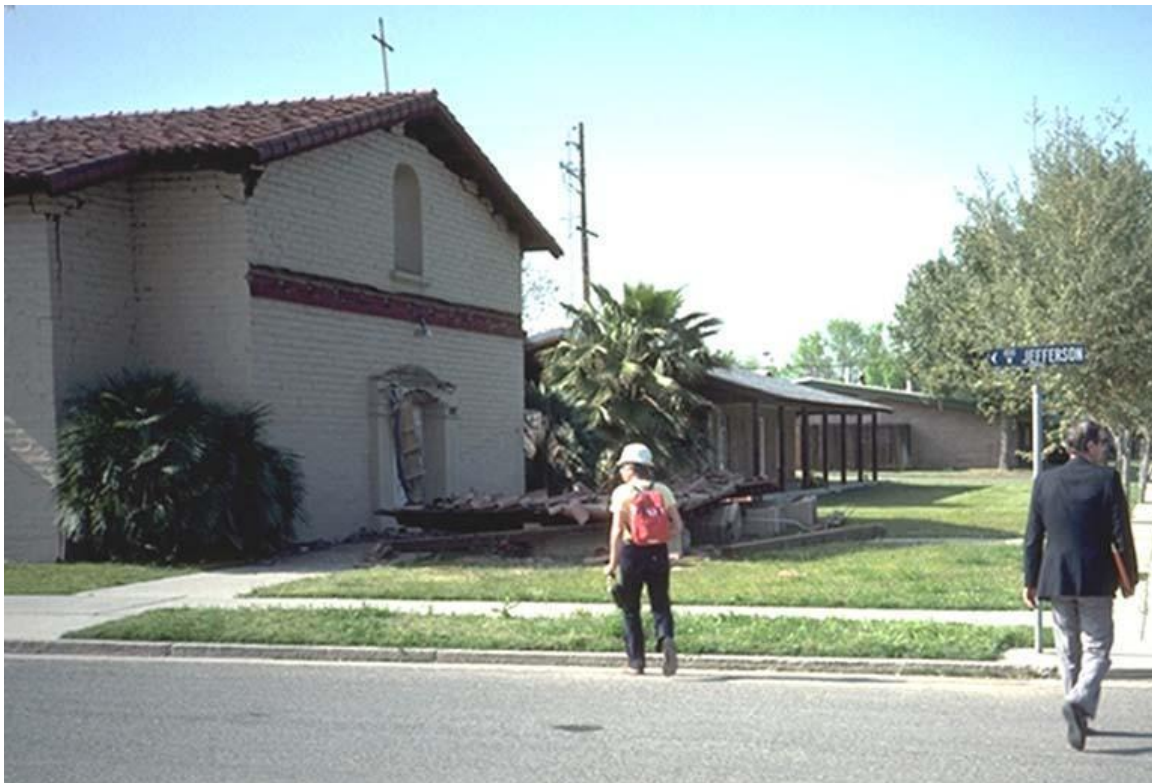
There are no other views of this building. Guess building area  $\approx 30 \text{ ft} \times 00 \text{ ft} = 2,700 \text{ ft}^2$ , guess porch measured  $20 \text{ ft} \times 10 \text{ ft} = 7\%$ .

**Figure 5–6.** Image showing porch pulled away from church building in the 1983 Coalinga, California, earthquake.

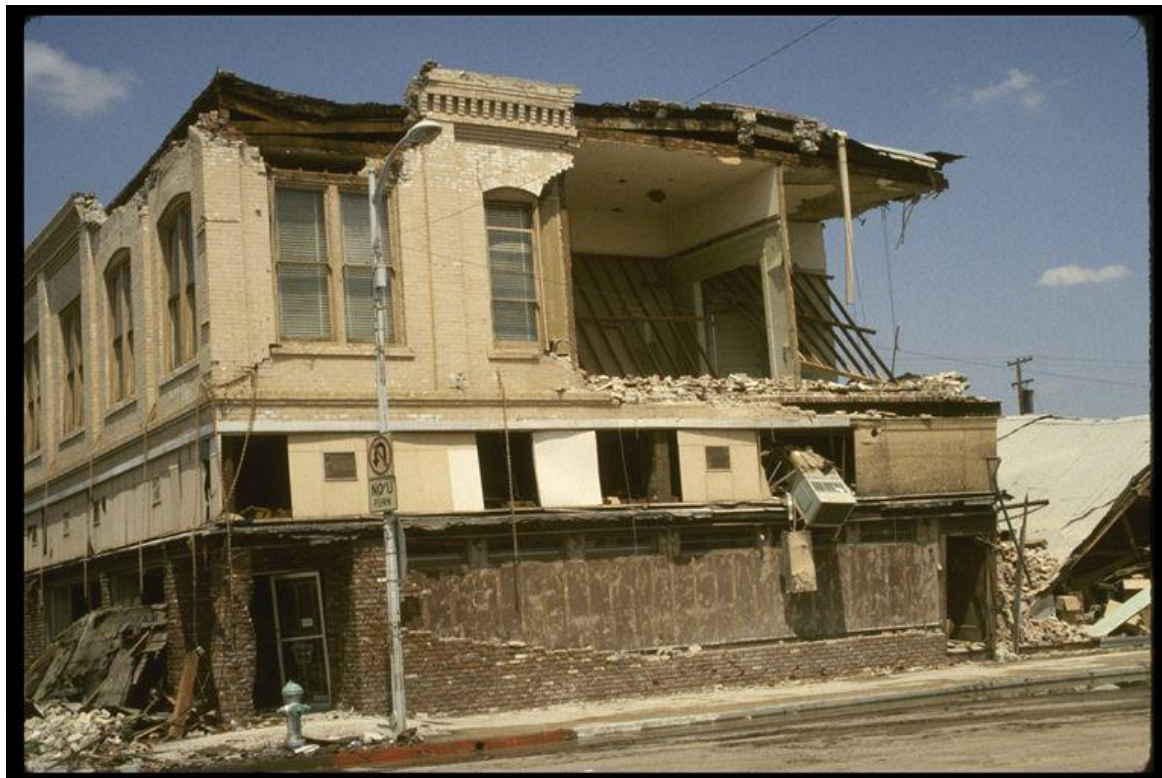
No long shots, no address, no estimate of affected area.

**Figure 5-7.** Image showing veneer fallen into first story of downtown building in the 1983 Coalinga, California, earthquake.

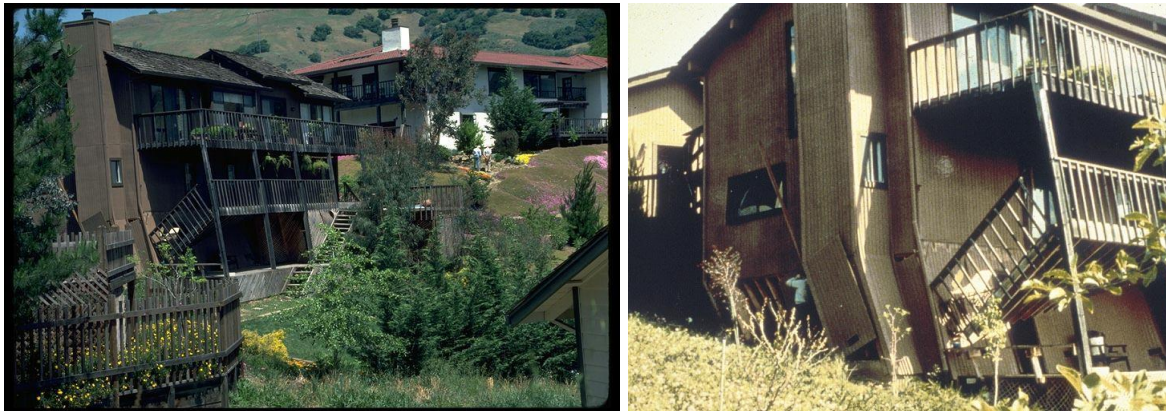
The right-hand image is from the FEMA National Earthquake Technical Assistance Training Program training slideset, entitled "Postearthquake Safety Evaluation of Buildings." Plan area from top to bottom floors appear to be 2:2:1. The bottom floor experienced some collapse, so say 20%.

**Figure 6–2.** Images showing dwellings that have moved, owing to landslide. Left image shows dwelling movement in the 1984 Morgan Hill, California, earthquake. Right image is from the Federal Emergency Management Agency (FEMA) National Earthquake Technical Assistance Training Program training slide set, entitled "Postearthquake Safety Evaluation of Buildings." It is in the public domain.

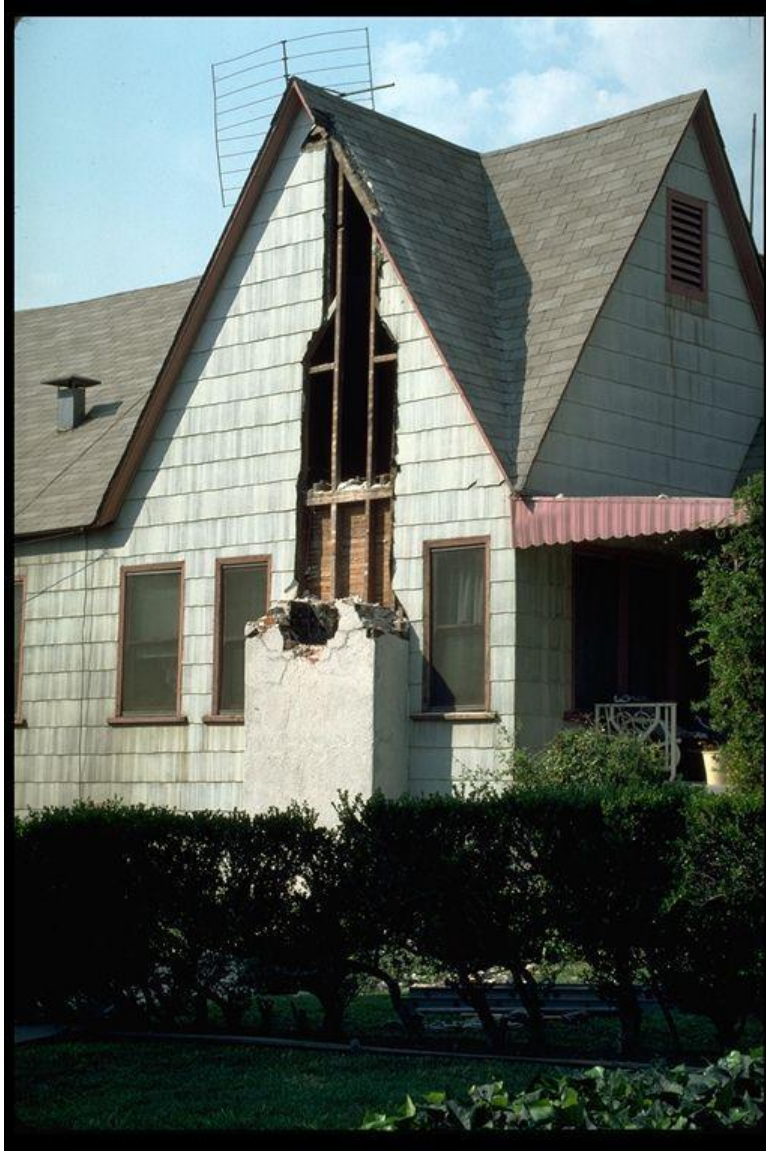
There are no other views of this house in adjacent records, so assume typical area 1,500 ft<sup>2</sup> and that bricks litter an area 5 ft × 10 ft = 3%.

**Figure 7-2.** Image showing collapsed chimney in a house in Whittier in the 1987 Whittier Narrows, California, earthquake.

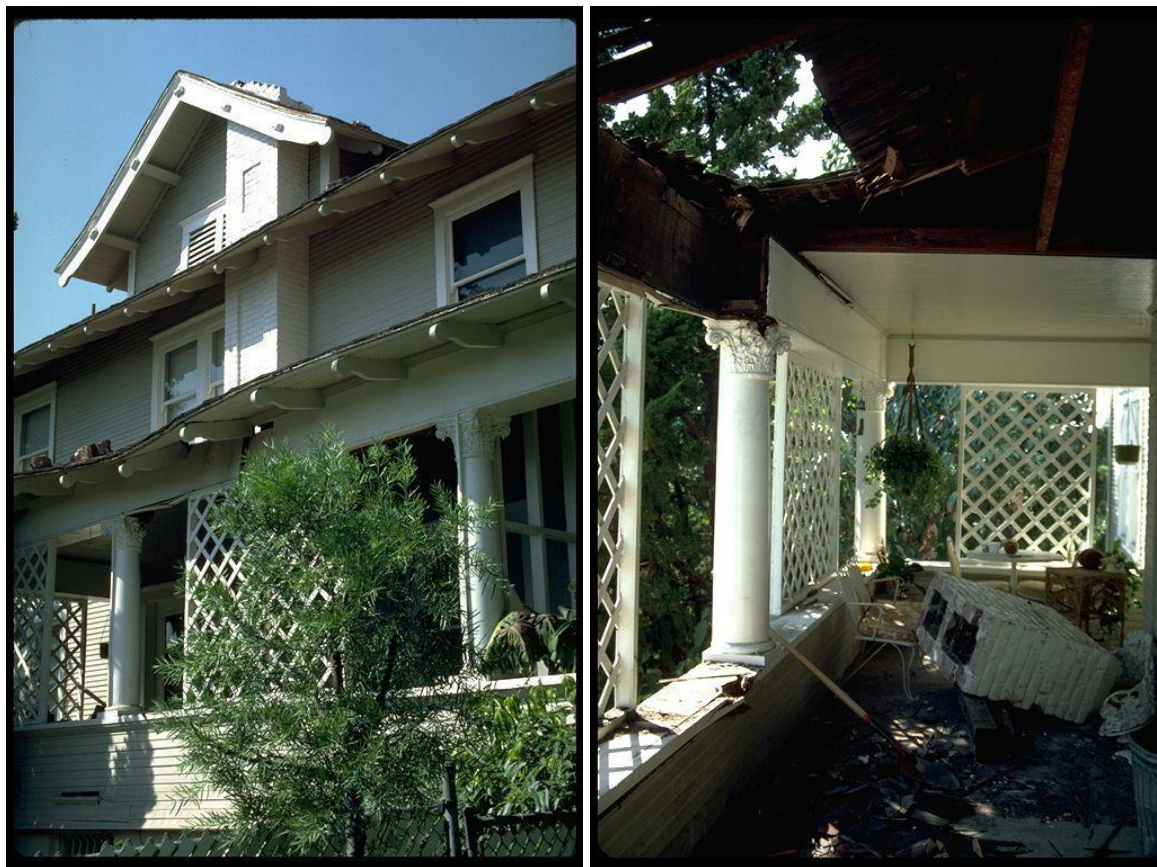
House looks larger than typical: assume 3,000 ft<sup>2</sup>. Bricks litter an area 8 ft × 8 ft = 2%.

Figure 7-3. Image showing collapsed chimney in the 1987 Whittier Narrows, California, earthquake.

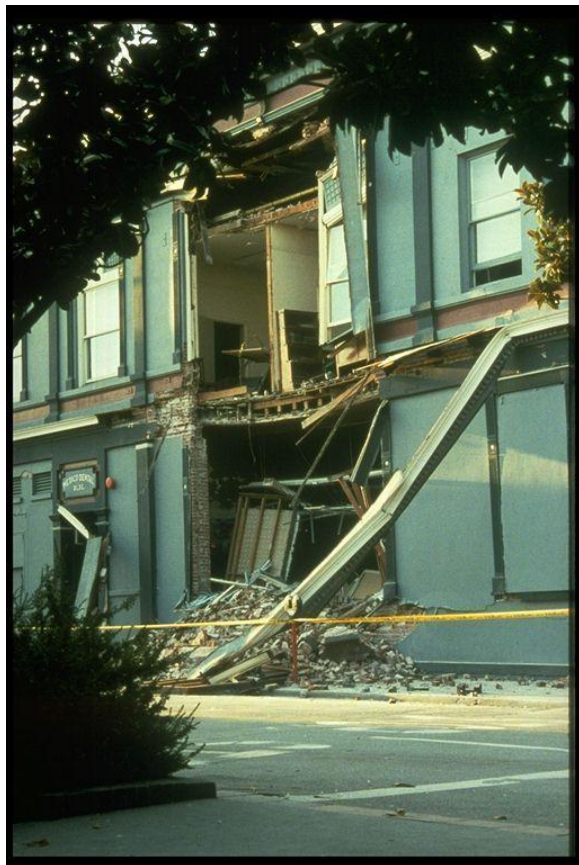
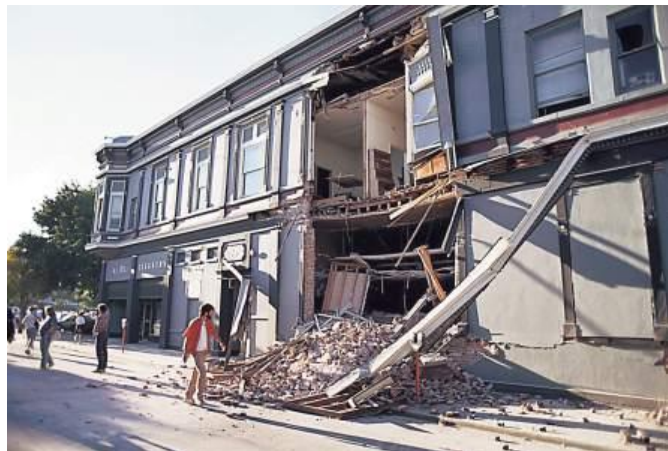
This is the historic Hihn Building, 1205 Pacific Avenue, Santa Cruz, CA 95060. The parcel (APN 00507517000) covers 8,180 ft<sup>2</sup> according to Google Earth. The building stood two stories tall in 1989.

Total building area = 16,360 ft<sup>2</sup>. Bricks litter an area about 16 ft × 12 ft, or 1%.

**Figure 8–1.** Photographs showing wall collapse in an unreinforced masonry (URM) building in the 1989 Loma Prieta, California, earthquake. Left image is from the Loma Prieta Blacklock Collection: LP0042. Right image shows a longer shot of the same building, copied from an article in the Press Democrat by Derek Moore, Oct 16, 2014, titled “Loma Prieta’s legacy, 25 years later (w/video)” (<http://www.pressdemocrat.com/news/2983451-181/loma-prietas-legacy-25-years>).

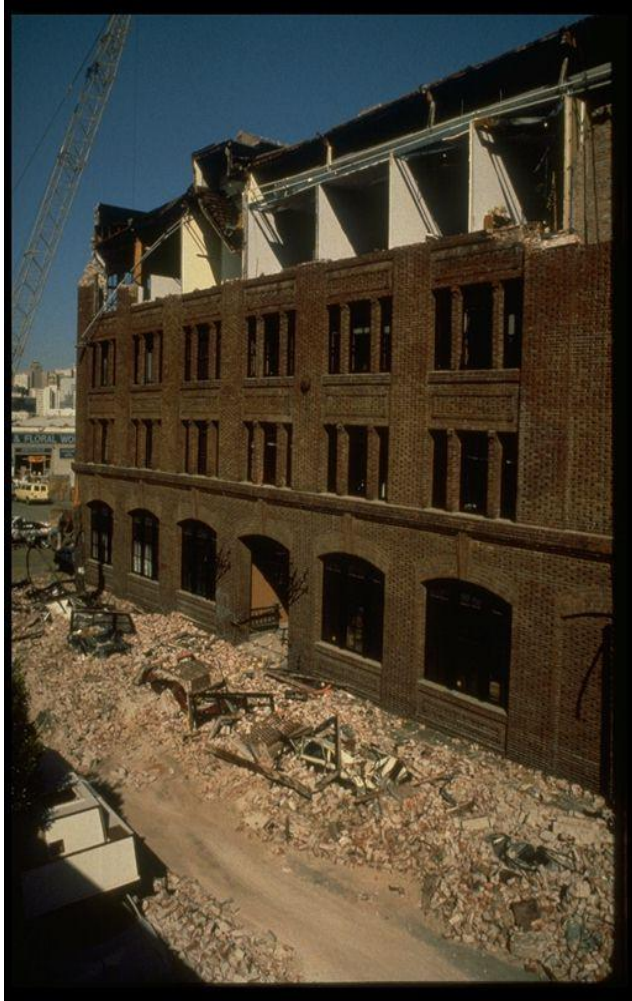
Also see LP0460. The location is sometimes reported as near 5th and Townsend Streets, sometimes on Bluxome Street near 6th and Townsend Streets. If the latter, the building appears to be 178 Bluxome Street, at the south end of Bluxome, north side of the street, APN 3785135, with parcel area 15,300 ft<sup>2</sup> according to Google Earth Pro. With four stories, the total building area would be 61,200 ft<sup>2</sup>. The debris runs the length of the facade (135 ft) and twice as wide as the sidewalk, perhaps 24 ft. Five people were killed by the wall collapse. Affected area =  $(135 \times 24)/(61,200) = 5.3\%$ .

**Figure 8–8.** Image showing collapse of fourth story wall from unreinforced brick building in the 1989 Loma Prieta, California, earthquake.

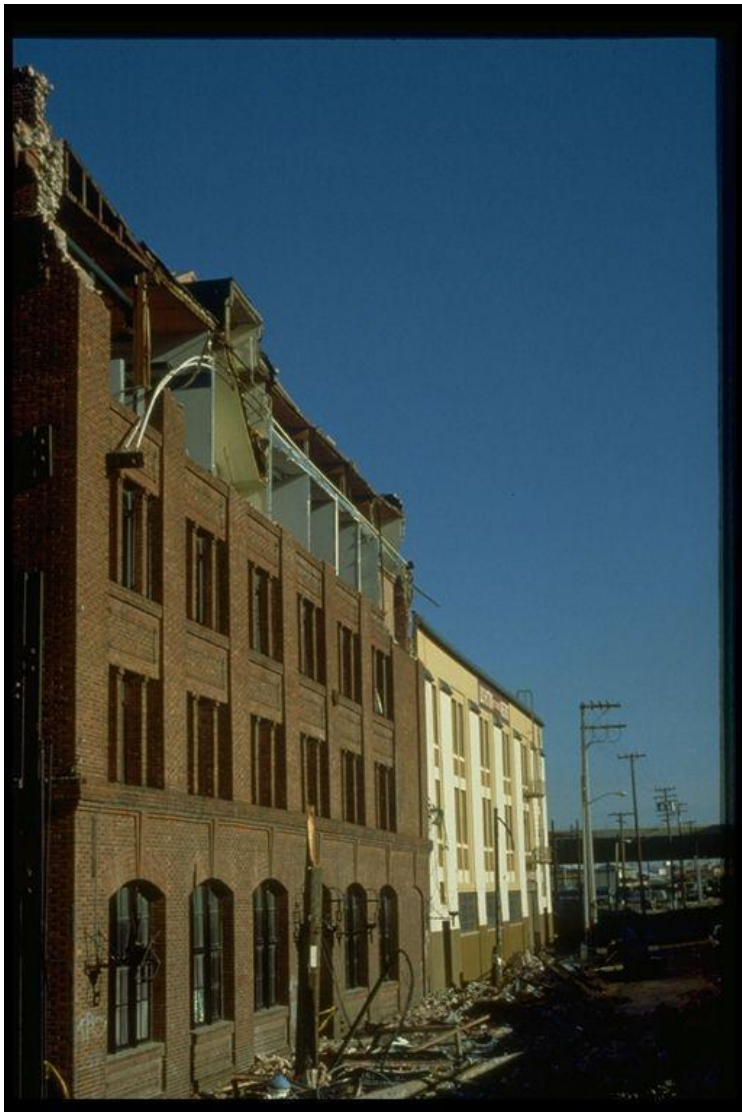
Same as LP0462.

**Figure 8–9.** Image showing collapse of unreinforced brick wall in the 1989 Loma Prieta, California, earthquake.
